## HUBER Technology at Inlet Works Awareness Day, Runcorn

### HUBER maintenance and service work

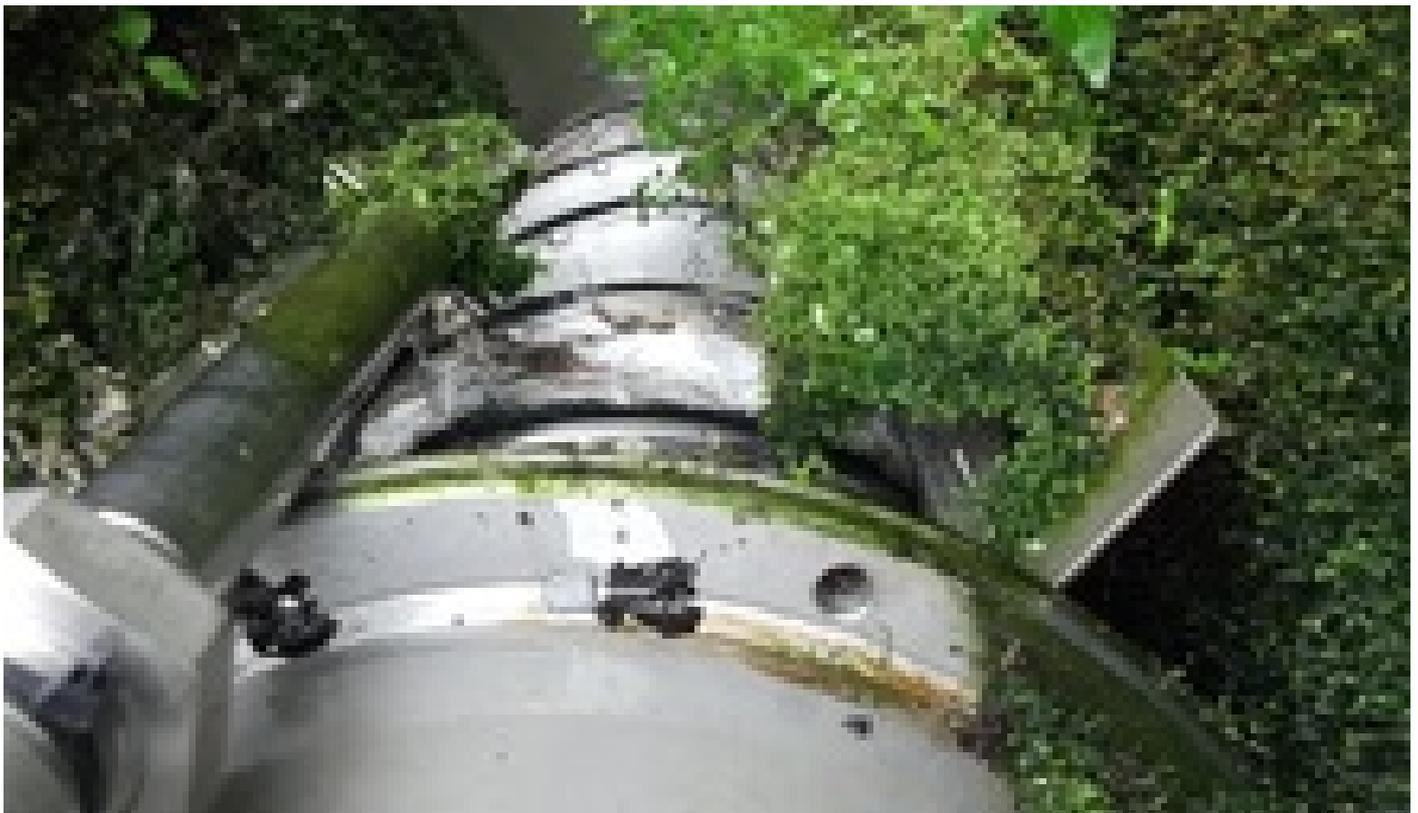
*HUBER Micro Strainer ROTAMAT® Ro9 disappearing into the undergrowth*

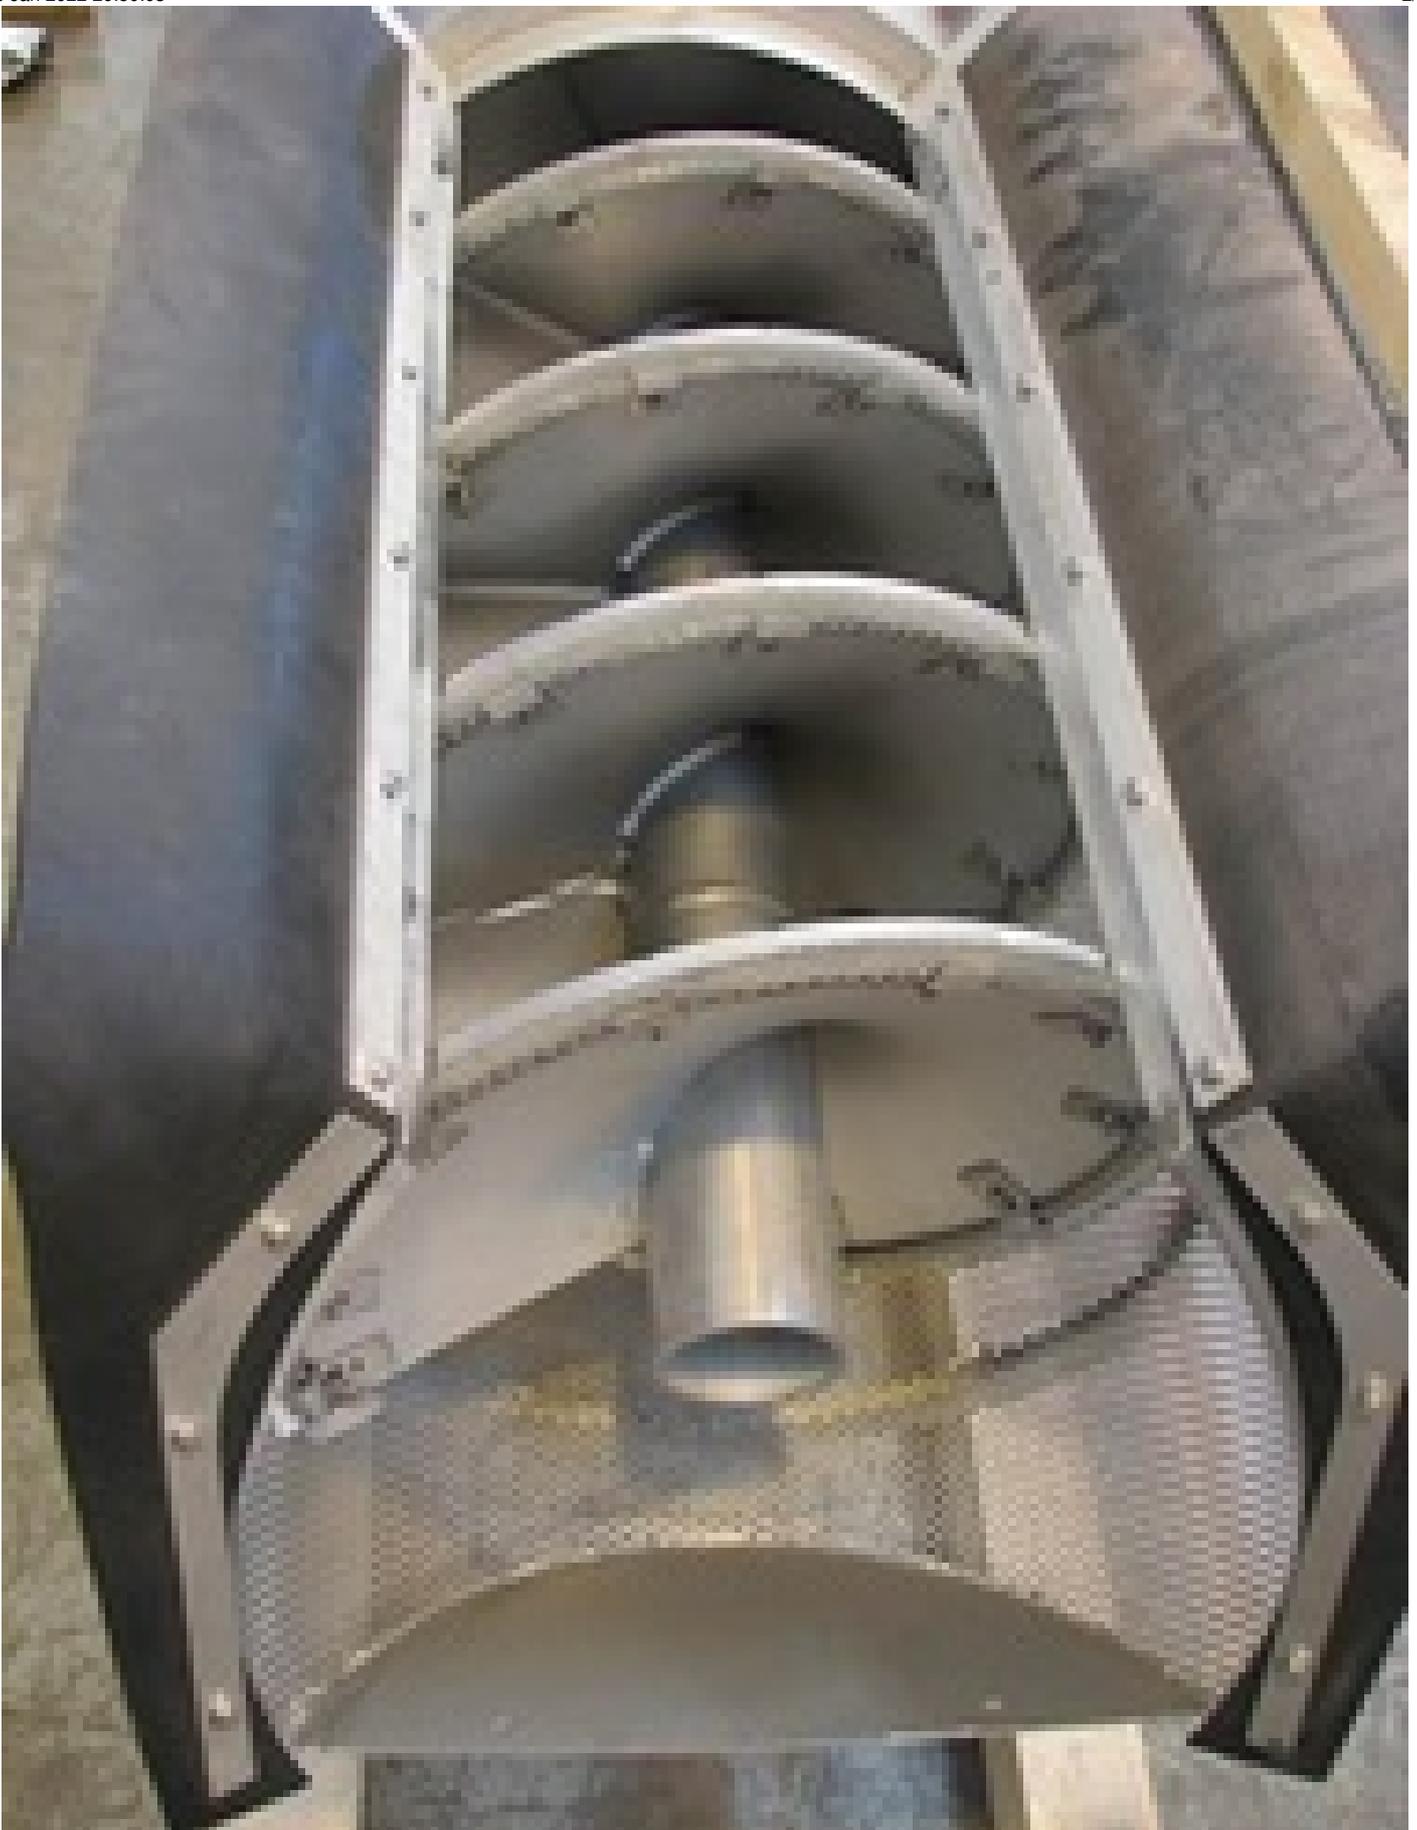
*Stainless steel shafted auger*

Unlike our competitors' equipment the Ro9 auger is of stainless steel construction and has a shaft running throughout its whole length. Having an auger shaft rather than an open spiral improves strength, allows for increased screenings compaction and prevents screenings tumbling down what would otherwise be an open helix when the screen is installed at steeper angles.

Extending the shaft through the basket was a design change introduced in 2007. This significantly increases the rigidity of the auger flights in the screening area and prevents distortion or concertinaing of screw flights if a large obstruction enters the basket.

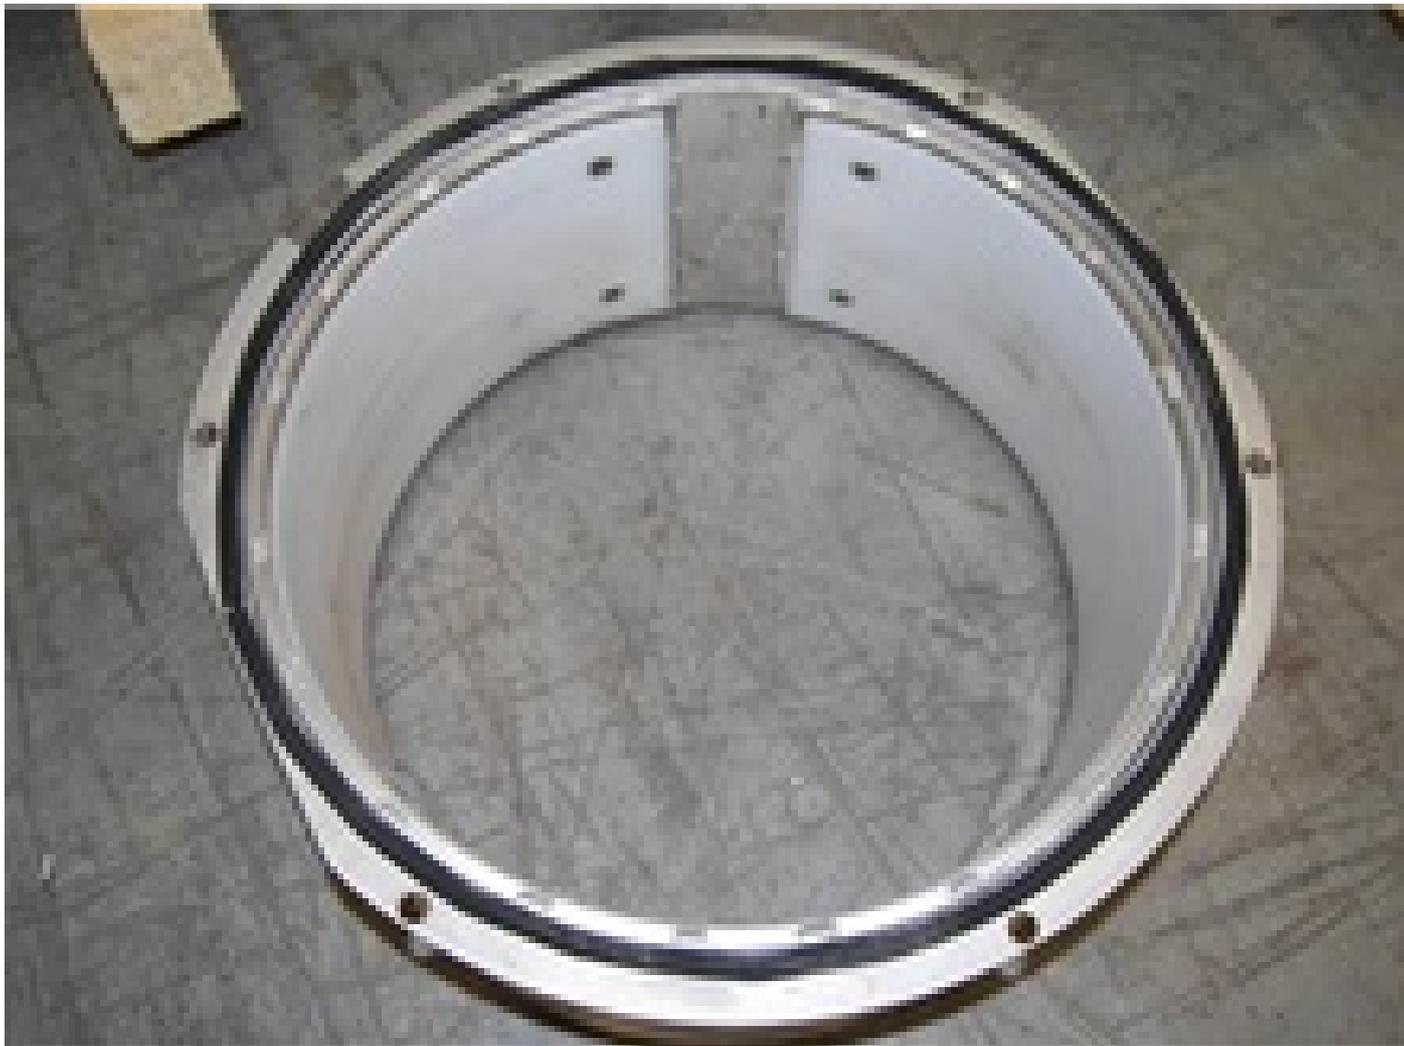
### **Intermediate shell bearing**

*Intermediate shell bearing*

Introduced in 2008, the intermediate shell bearing located just above the perforated screen basket fully supports the auger at the non-drive end of the screen. The polyethylene bearing shell supports the auger, reduces the contact pressure between the auger brushes and the basket, reducing brush wear rates and also preventing metal to metal contact and wear between the auger and basket (if the auger brush is not replaced once it's become worn). By not relying on the auger brush to support the auger at the non-drive end, brush life is considerably extended. The use of a shell bearing as opposed to a submerged bearing at the non-drive end of the auger shaft ensures that there is no obstruction in the flow which would be susceptible to becoming bound up with screenings.
