Charfield STW Case Study: Inlet Screen Replacement Project

As part of the Wessex Water inlet screen replacement projects, HUBER Technology completed the delivery and installation of a new inlet screen and screenings handling project at Charfield STW near Wooton under Edge.

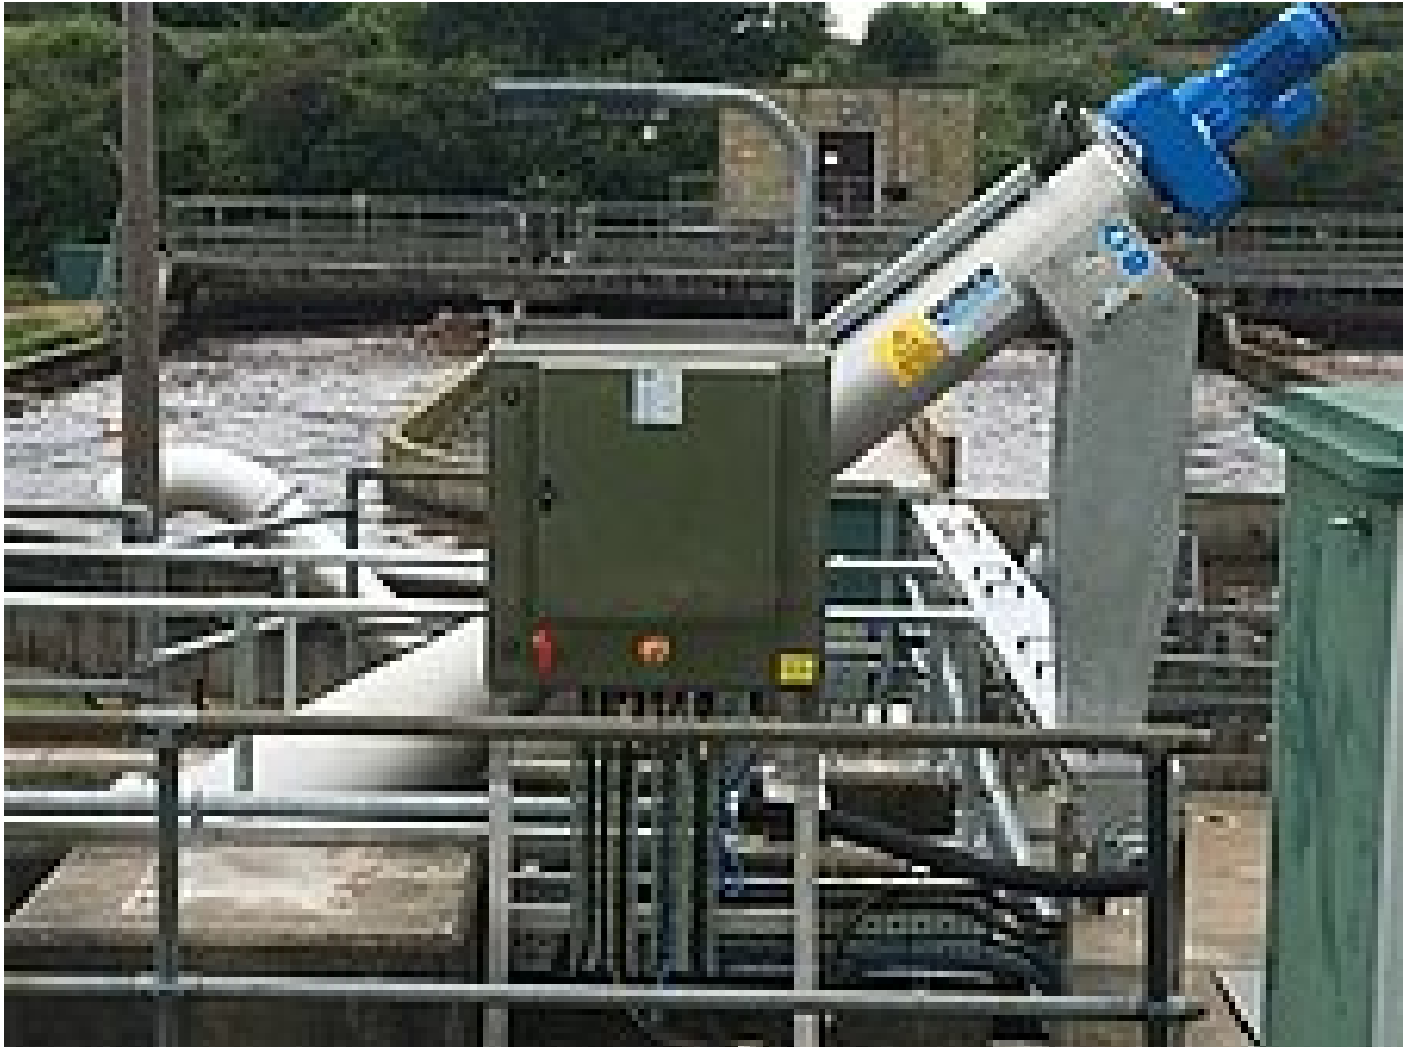
HUBER Micro Strainer ROTAMAT® Ro9 installed at Charfield STW

We modified our combined screen (HUBER Micro Strainer ROTAMAT® Ro9) so that it ran without washwater and no compaction, it was essentially a conveyor to elevate the screens into a small washpactor (Washpress WAP®/L). This Inlet screen was one of the first Ro9's without the washwater feature to be supplied into the UK for the Wessex Water inlet screen replacement projects. This innovative idea of discharging from the Ro9 into a launder was a success and is currently working extremely well.

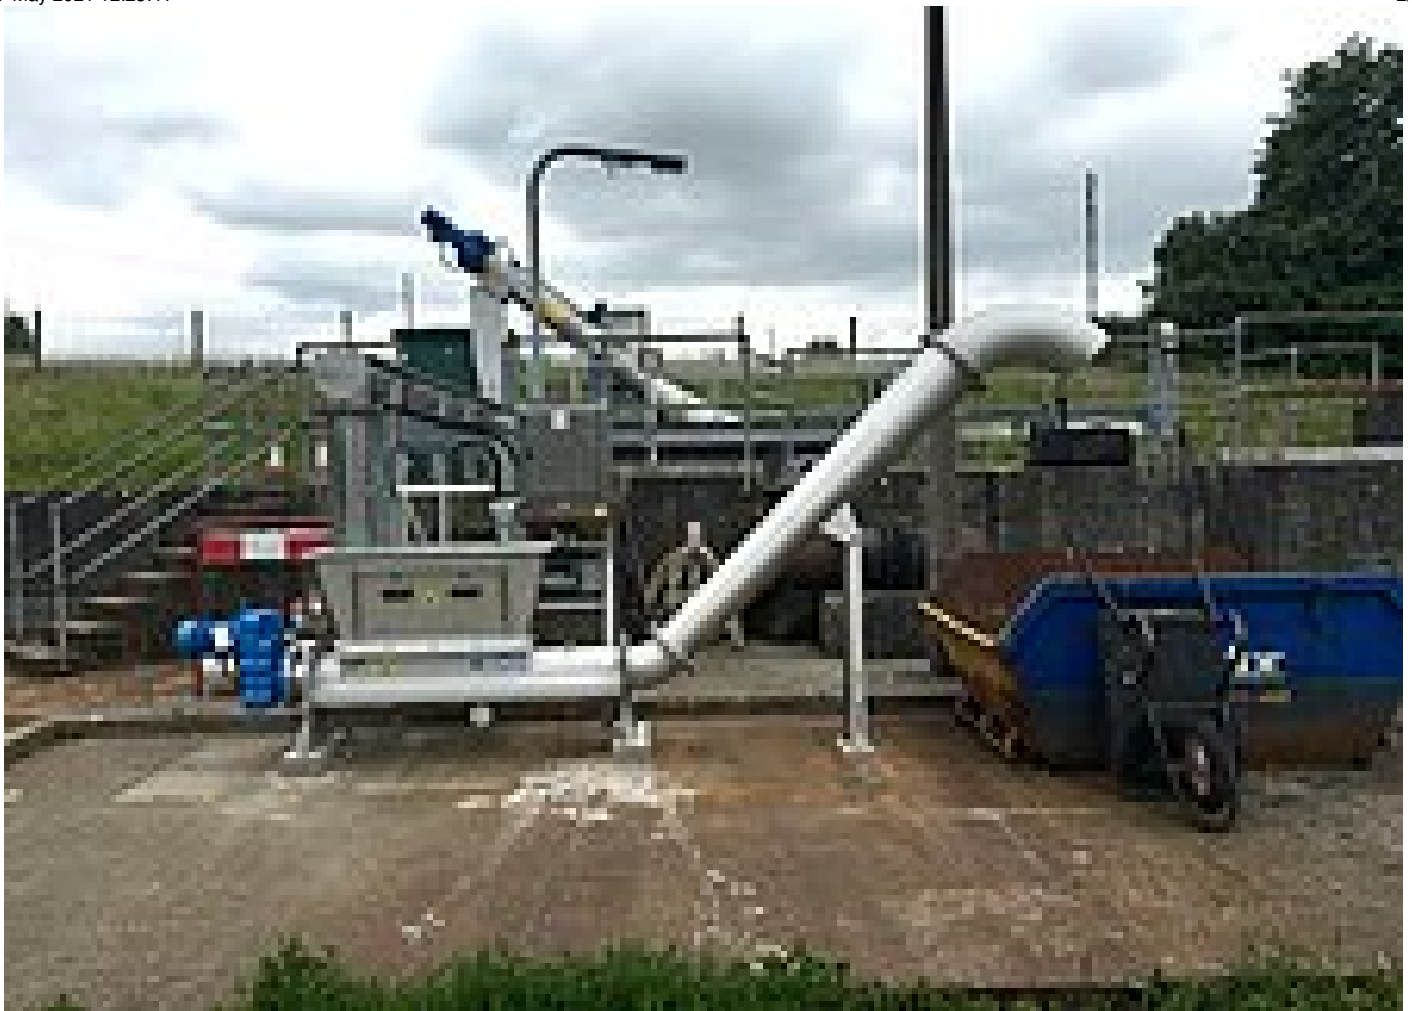
The complete HUBER installation with Wash Press WAP®/L in the foreground

- Screenings Wash Press WAP®/L size 2 screenings handling unit
- Control Panels
- HUBER Launder Channel HLC

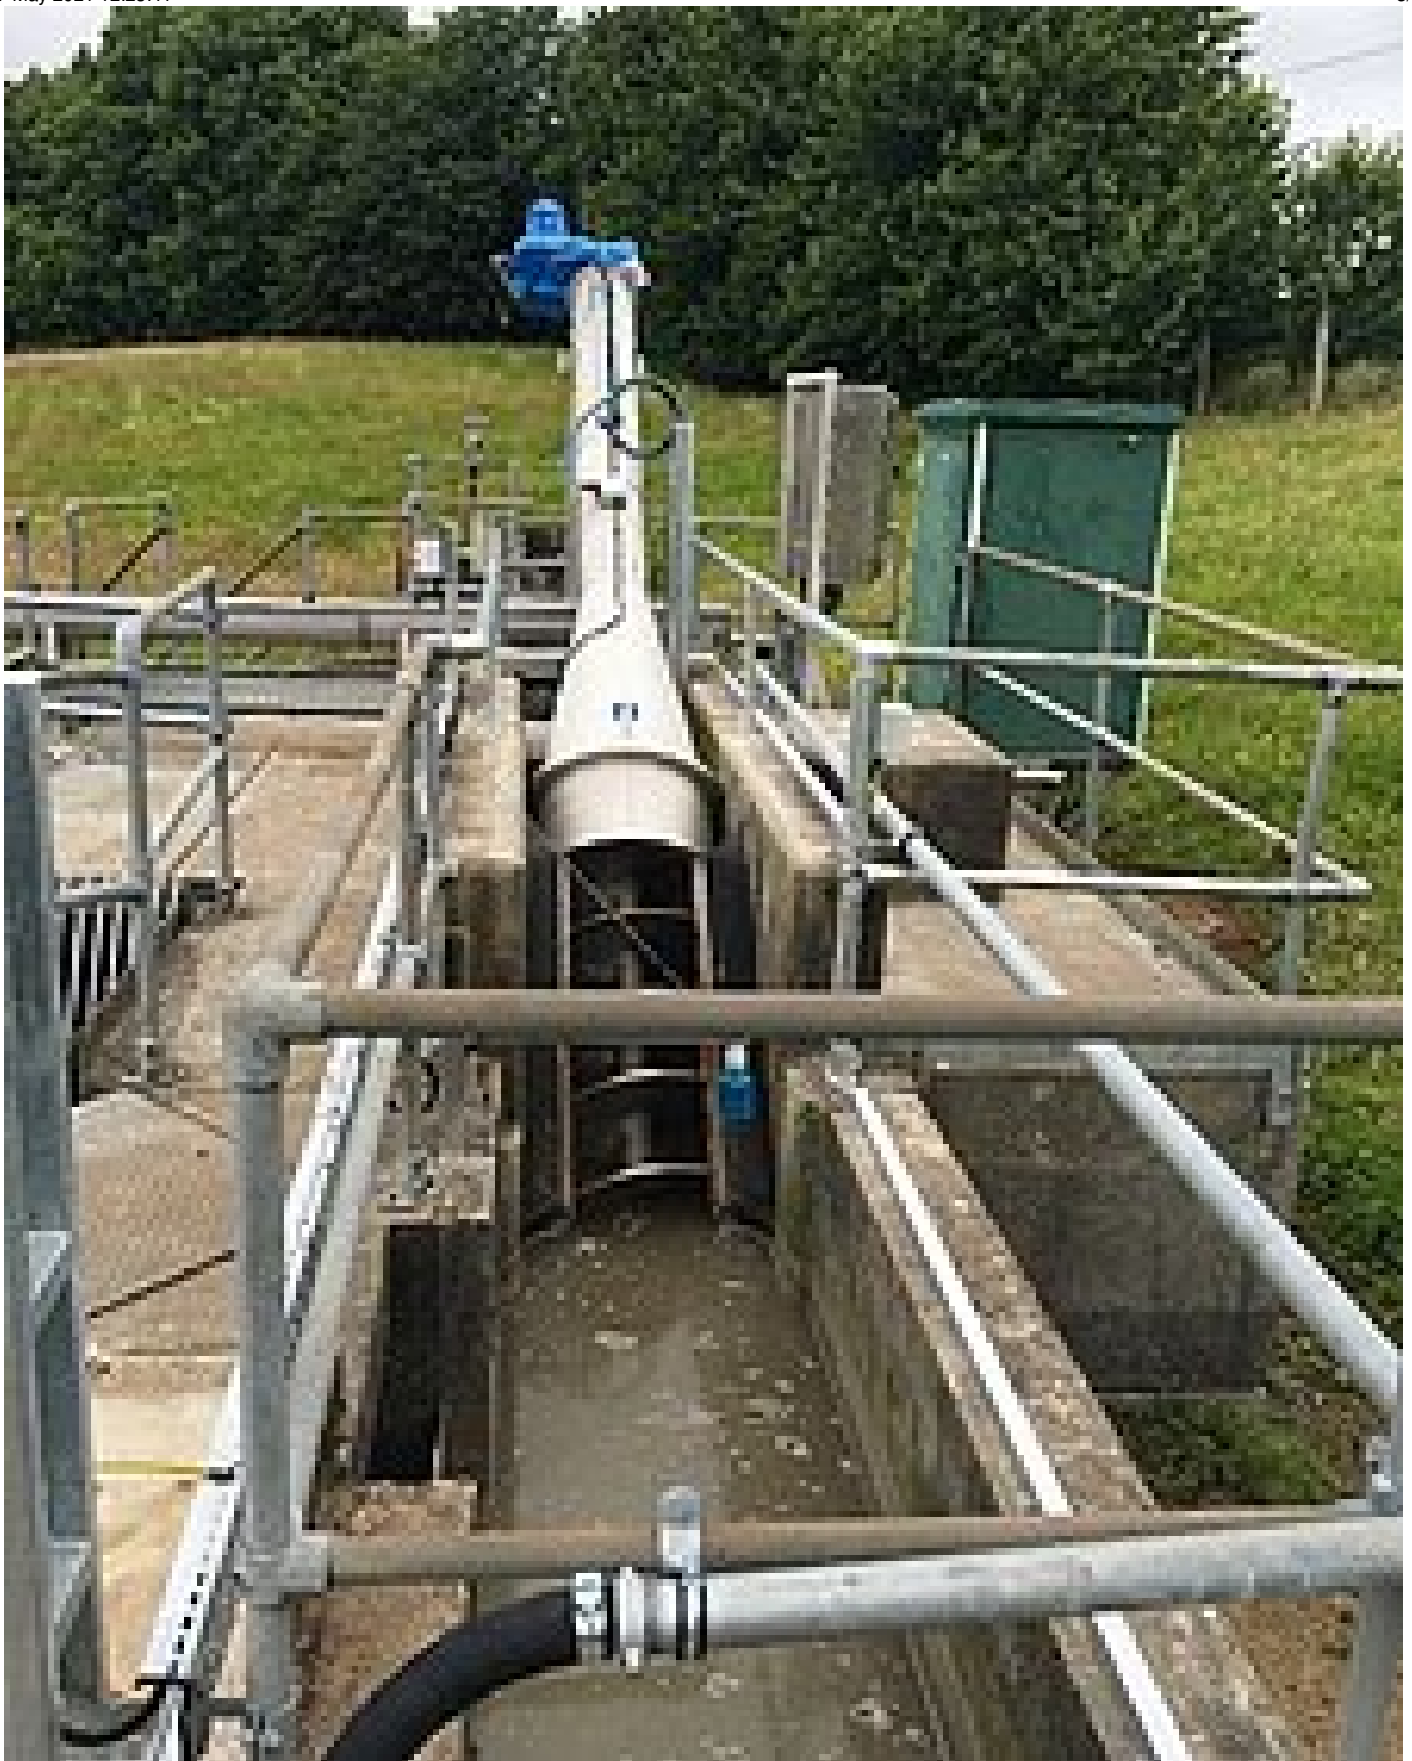
The modified HUBER Micro Strainer ROTAMAT® Ro9 in the inlet screen channel

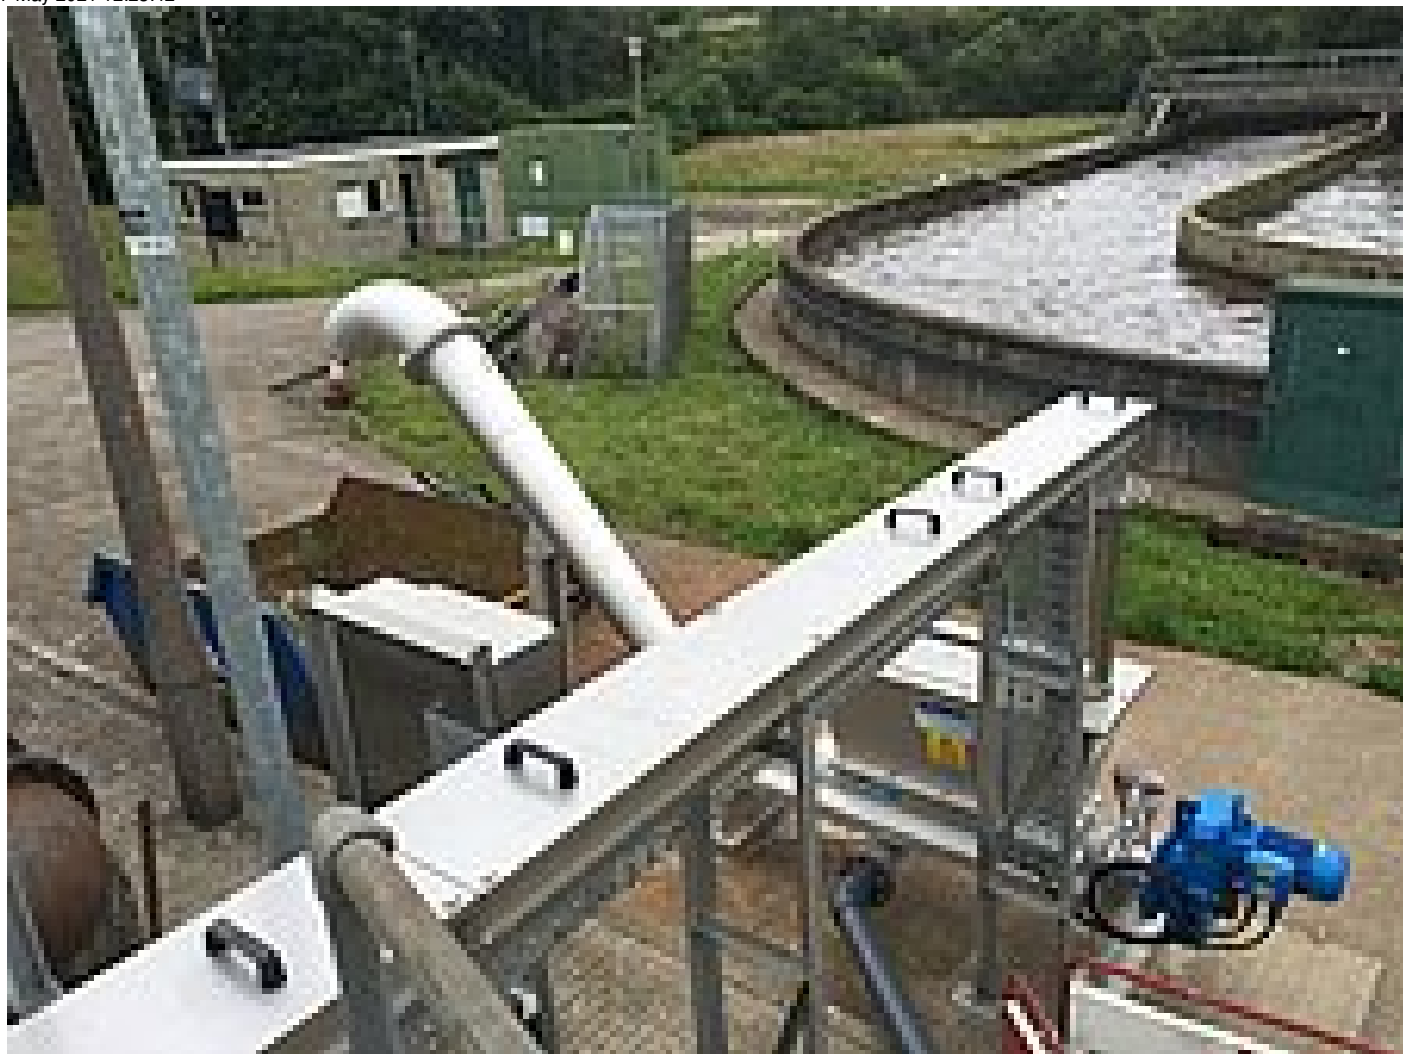
Launder Channel feeding the Wash Press

The lack of washwater for the launder resulted in an additional modification - Wessex Water fitting a submersible pump in a chamber upfront of the screen, this chamber had a 6mm perforated plate upfront to prevent large rag blocking the pump. The pump starter was included in our control panel and was linked to the screen start.

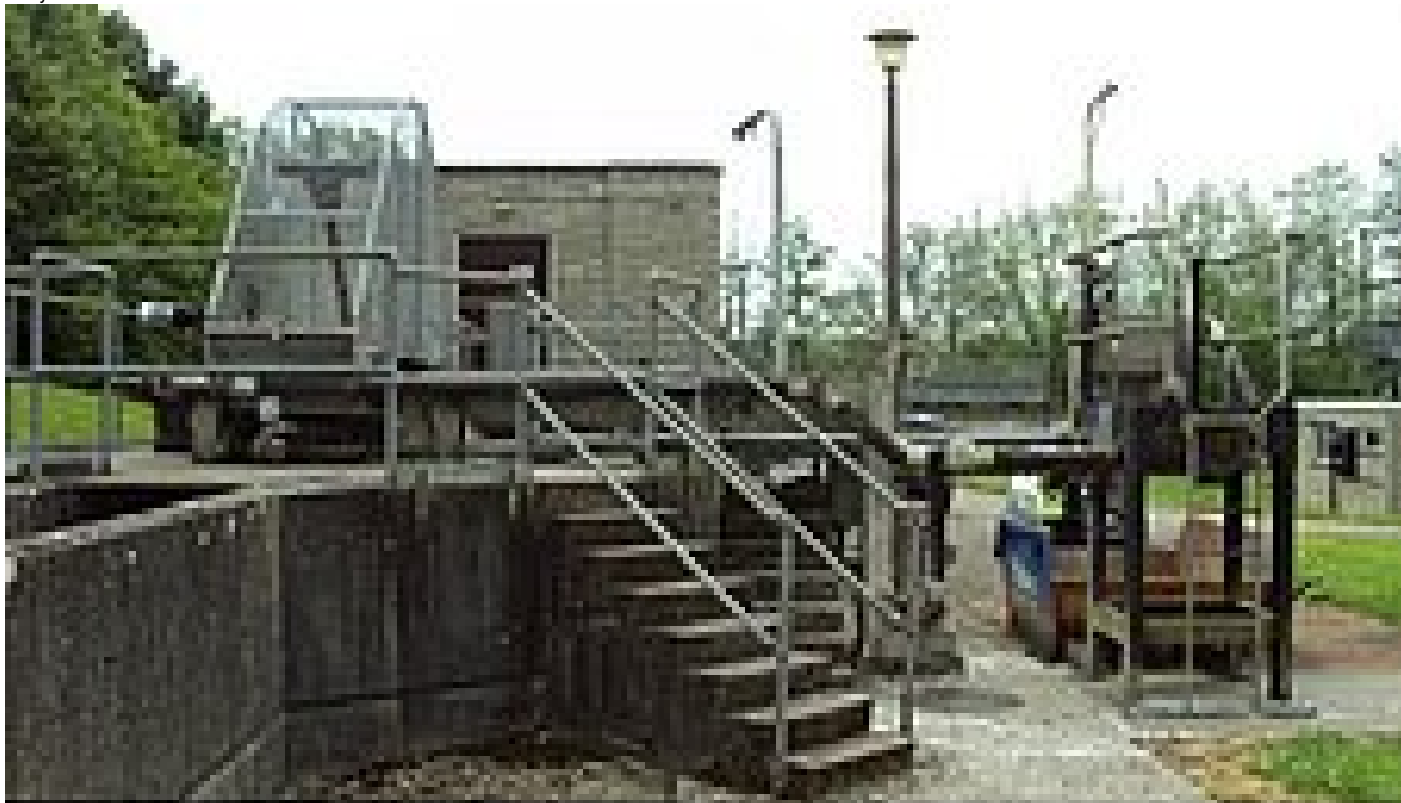
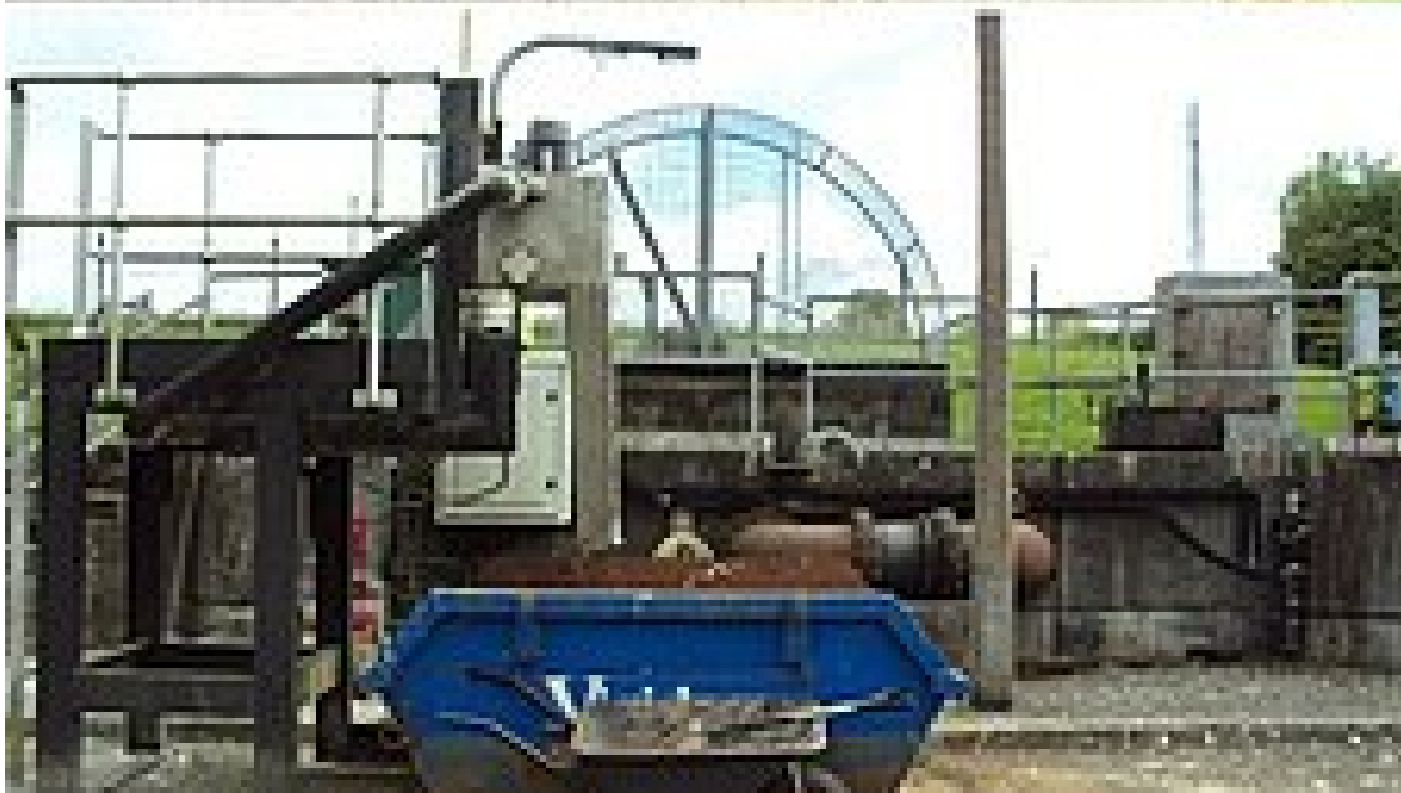
The old equipment installed was at the end of its asset life and constantly failing

Installed on site was an old 20mm bar screen discharging into a launder feeding a macerator and licep unit. All the equipment installed were at the end of their asset life and were constantly failing. The inlet screen was also allowing rag to bypass it due to its age.
