Charfield STW Case Study: Inlet Screen Replacement Project

As part of the Wessex Water inlet screen replacement projects, HUBER Technology completed the delivery and installation of a new inlet screen and screenings handling project at Charfield STW near Wootton under Edge.

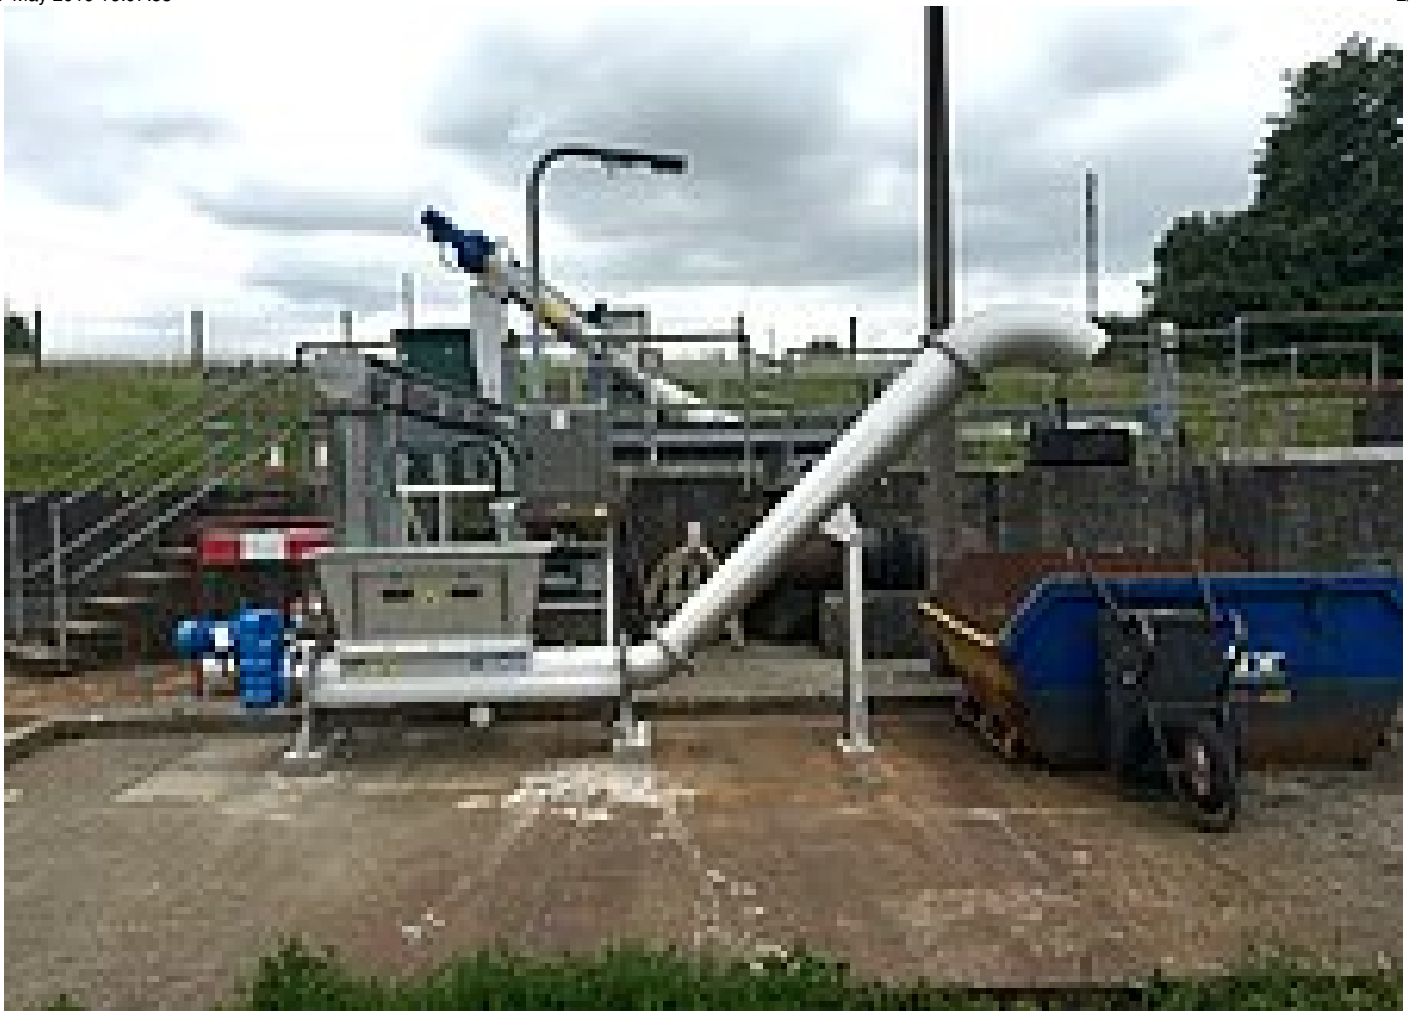
The complete HUBER installation with Wash Press WAP®/L in the foreground

- Screenings Wash Press WAP®/L size 2 screenings handling unit
- Control Panels
- HUBER Launder Channel HLC

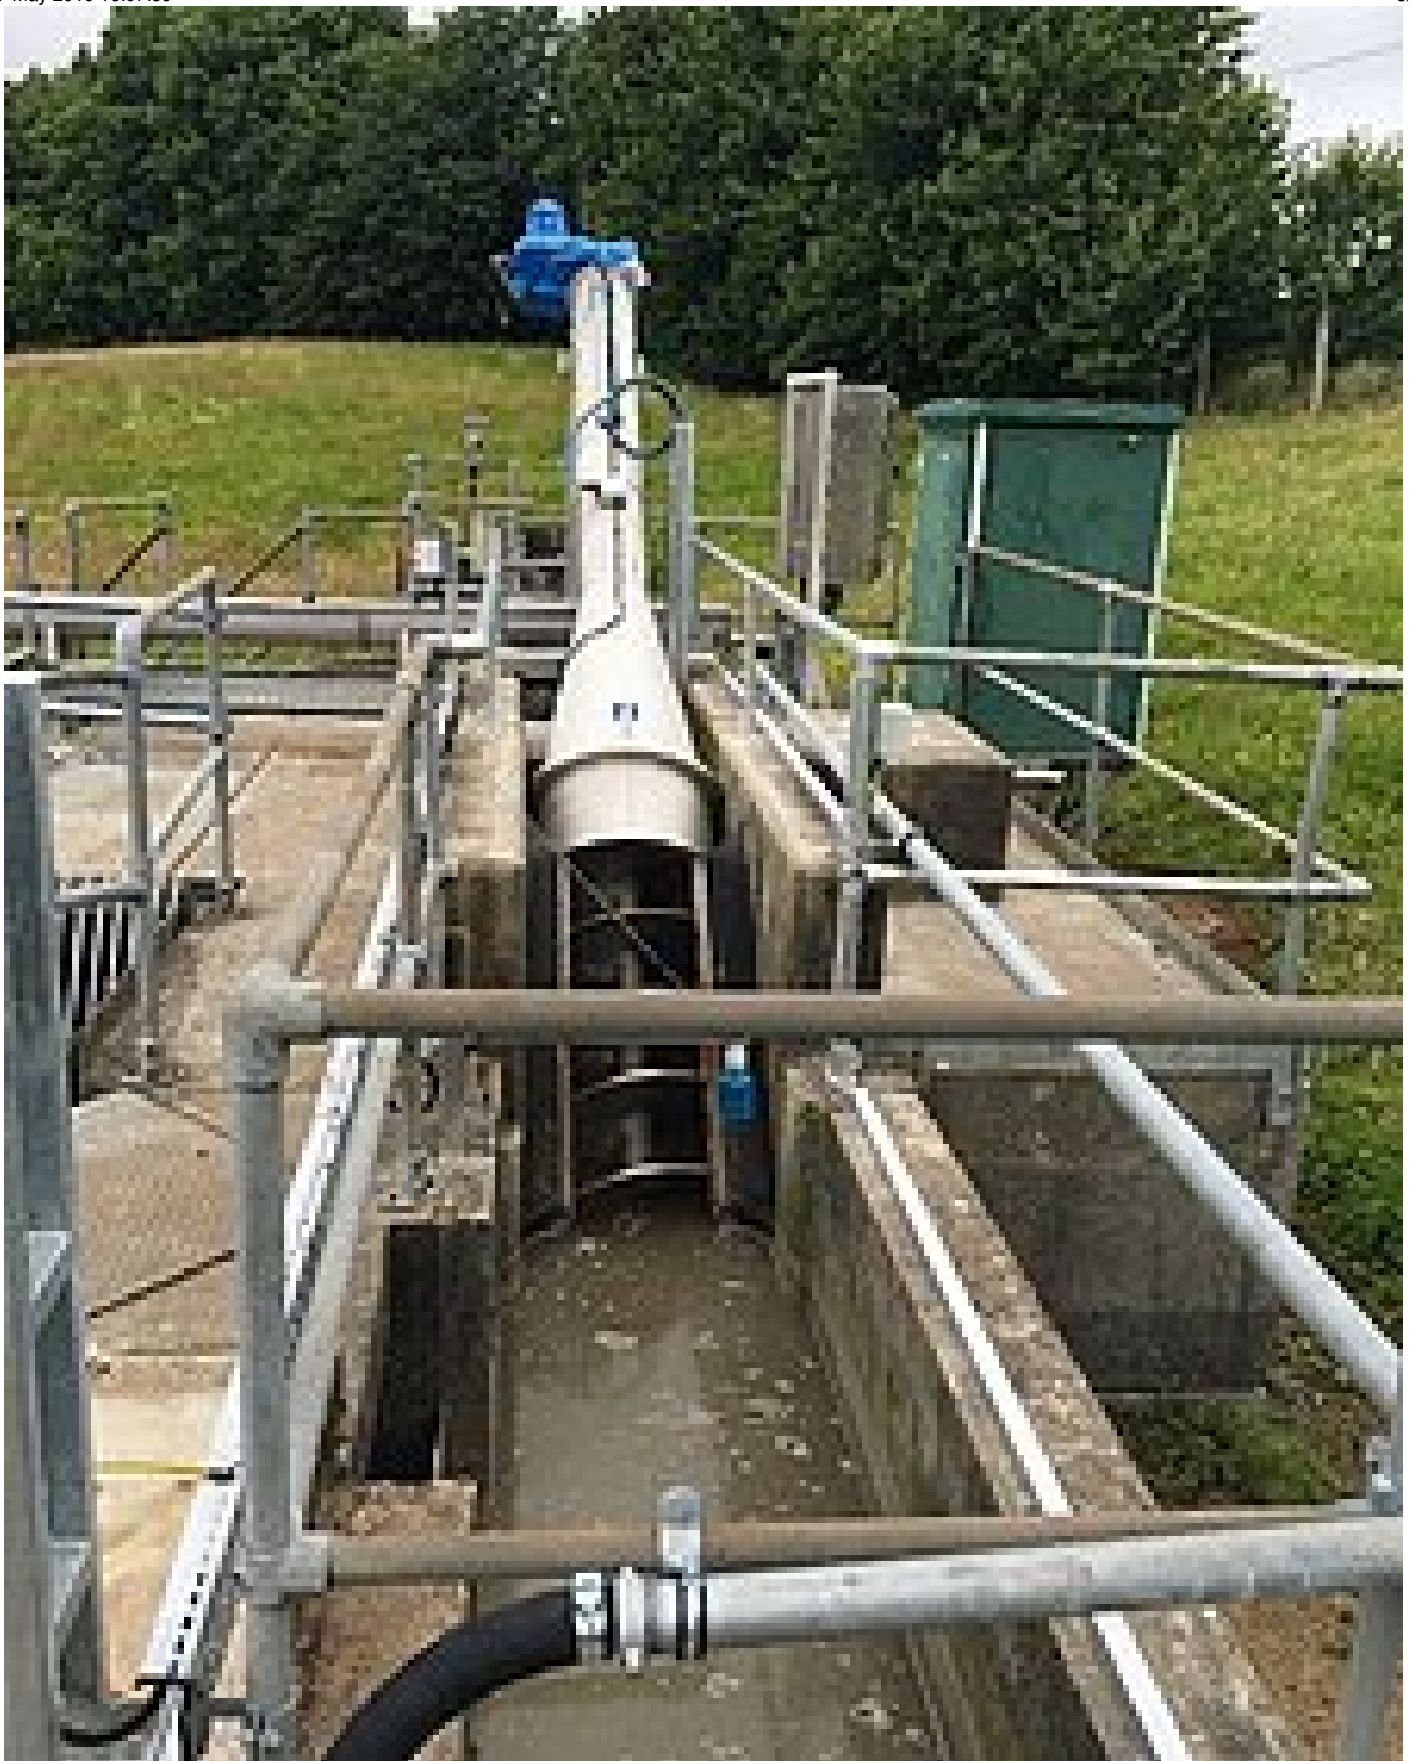
The modified HUBER Micro Strainer ROTAMAT® Ro9 in the inlet screen channel

We modified our combined screen (HUBER Micro Strainer ROTAMAT® Ro9) so that it ran without washwater and no compaction, it was essentially a conveyor to elevate the screens into a small washpactor (Washpress WAP®/L). This Inlet screen was one of the first Ro9's without the washwater feature to be supplied into the UK for the Wessex Water inlet screen replacement projects. This innovative idea of discharging from the Ro9 into a launder was a success and is currently working extremely well.

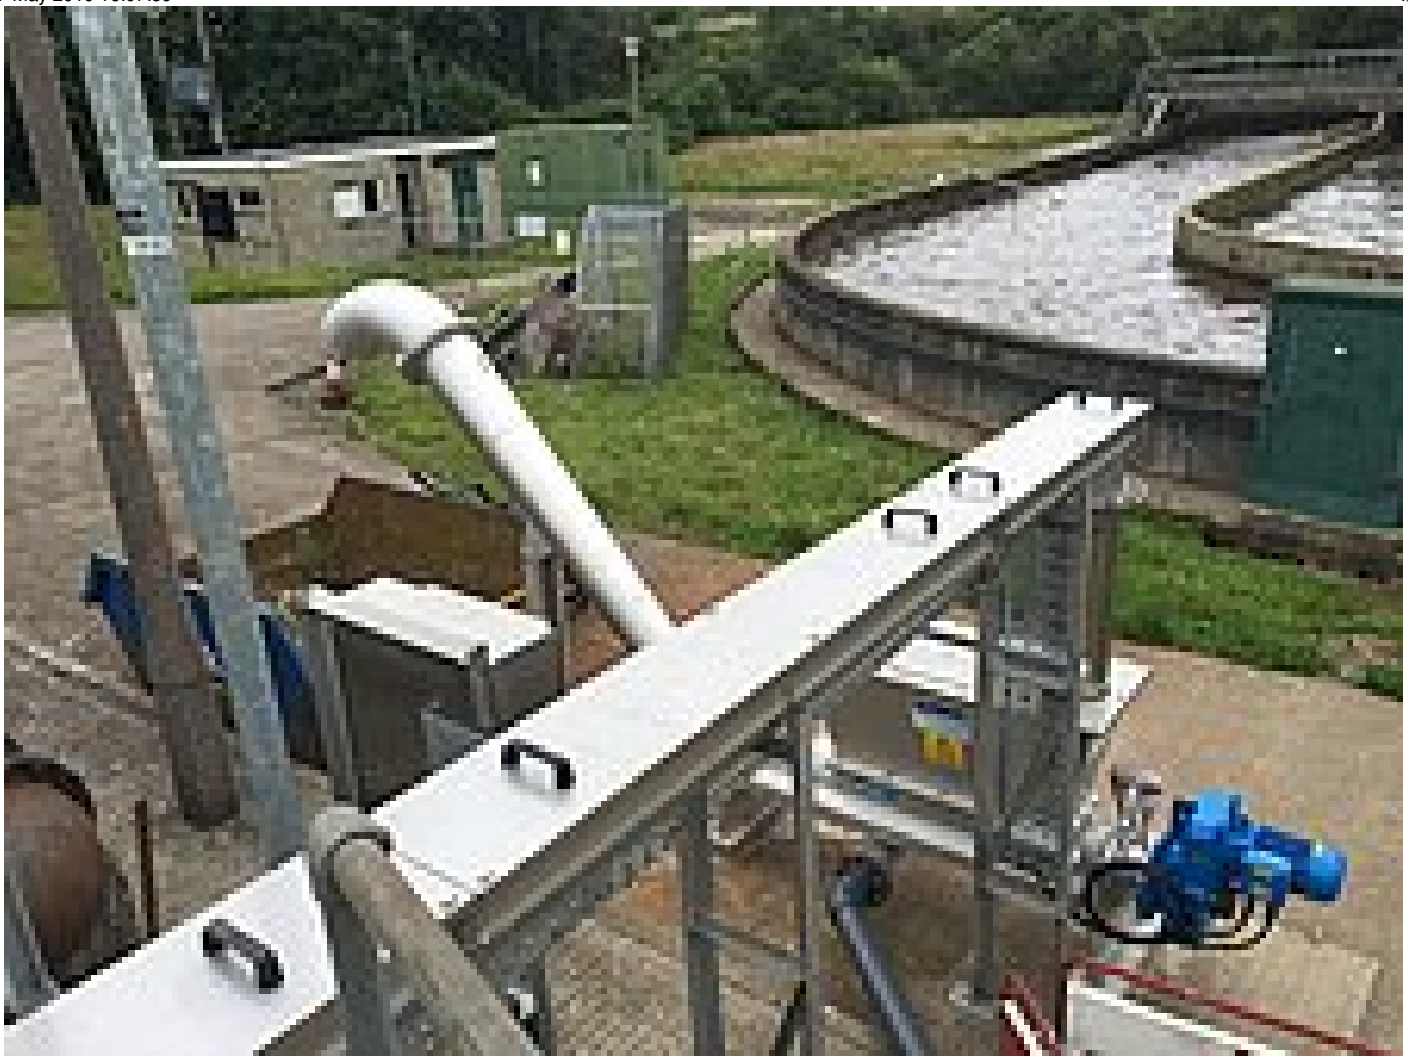
Launder Channel feeding the Wash Press

The lack of washwater for the launder resulted in an additional modification - Wessex Water fitting a submersible pump in a chamber upfront of the screen, this chamber had a 6mm perforated plate upfront to prevent large rag blocking the pump. The pump starter was included in our control panel and was linked to the screen start.

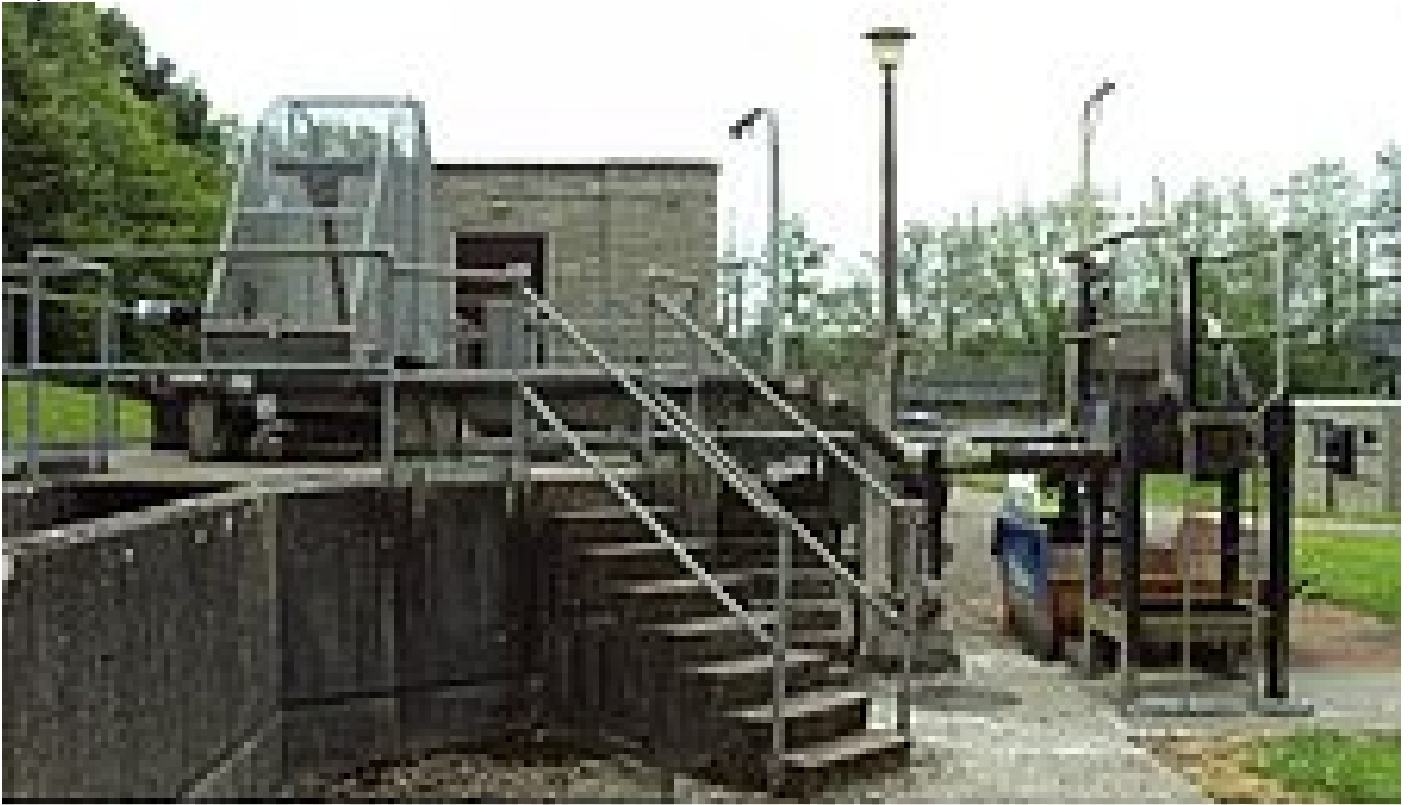
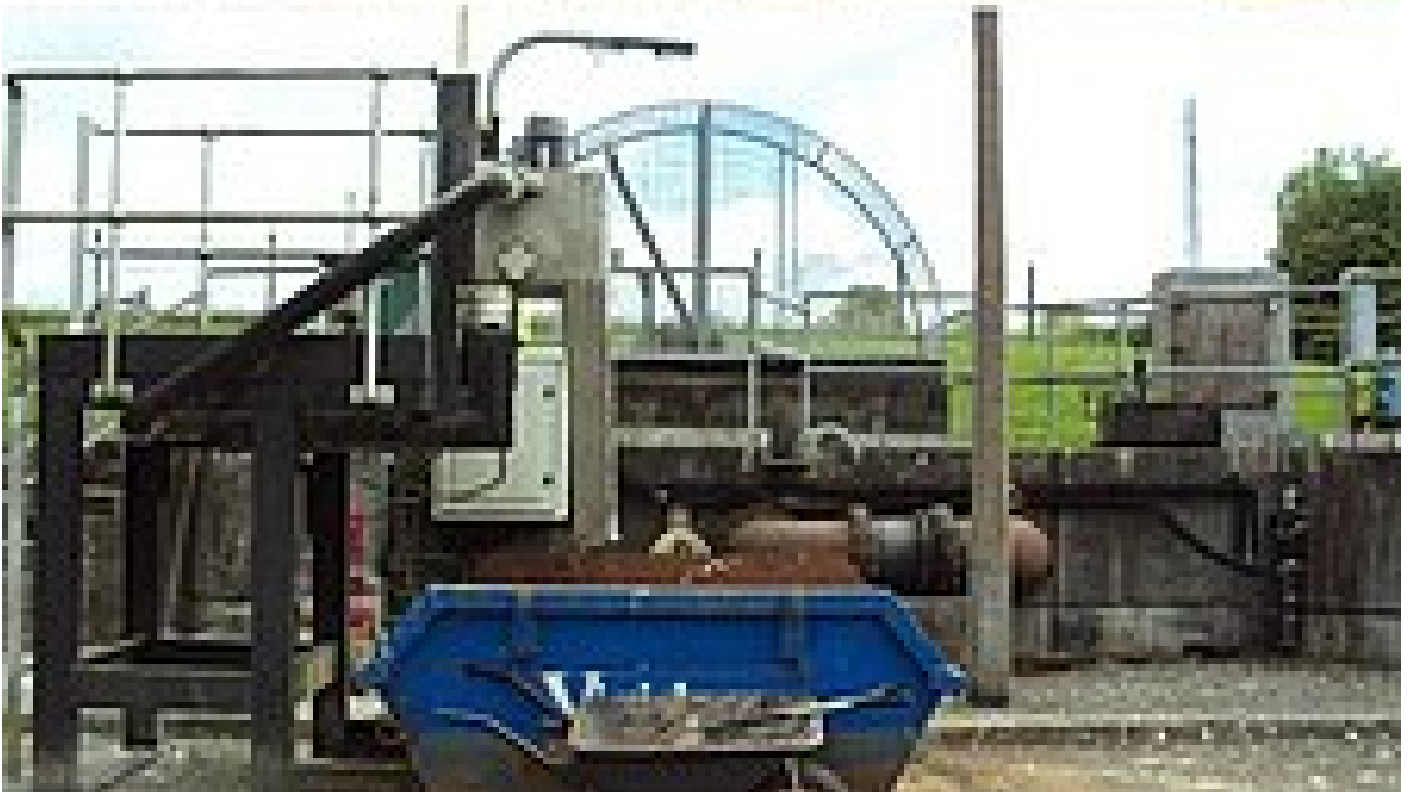
The old equipment installed was at the end of its asset life and constantly failing

Installed on site was an old 20mm bar screen discharging into a launder feeding a macerator and licep unit. All the equipment installed were at the end of their asset life and were constantly failing. The inlet screen was also allowing rag to bypass it due to its age.
