Charfield STW Case Study: Inlet Screen Replacement Project

As part of the Wessex Water inlet screen replacement projects, HUBER Technology completed the delivery and installation of a new inlet screen and screenings handling project at Charfield STW near Wootton under Edge.

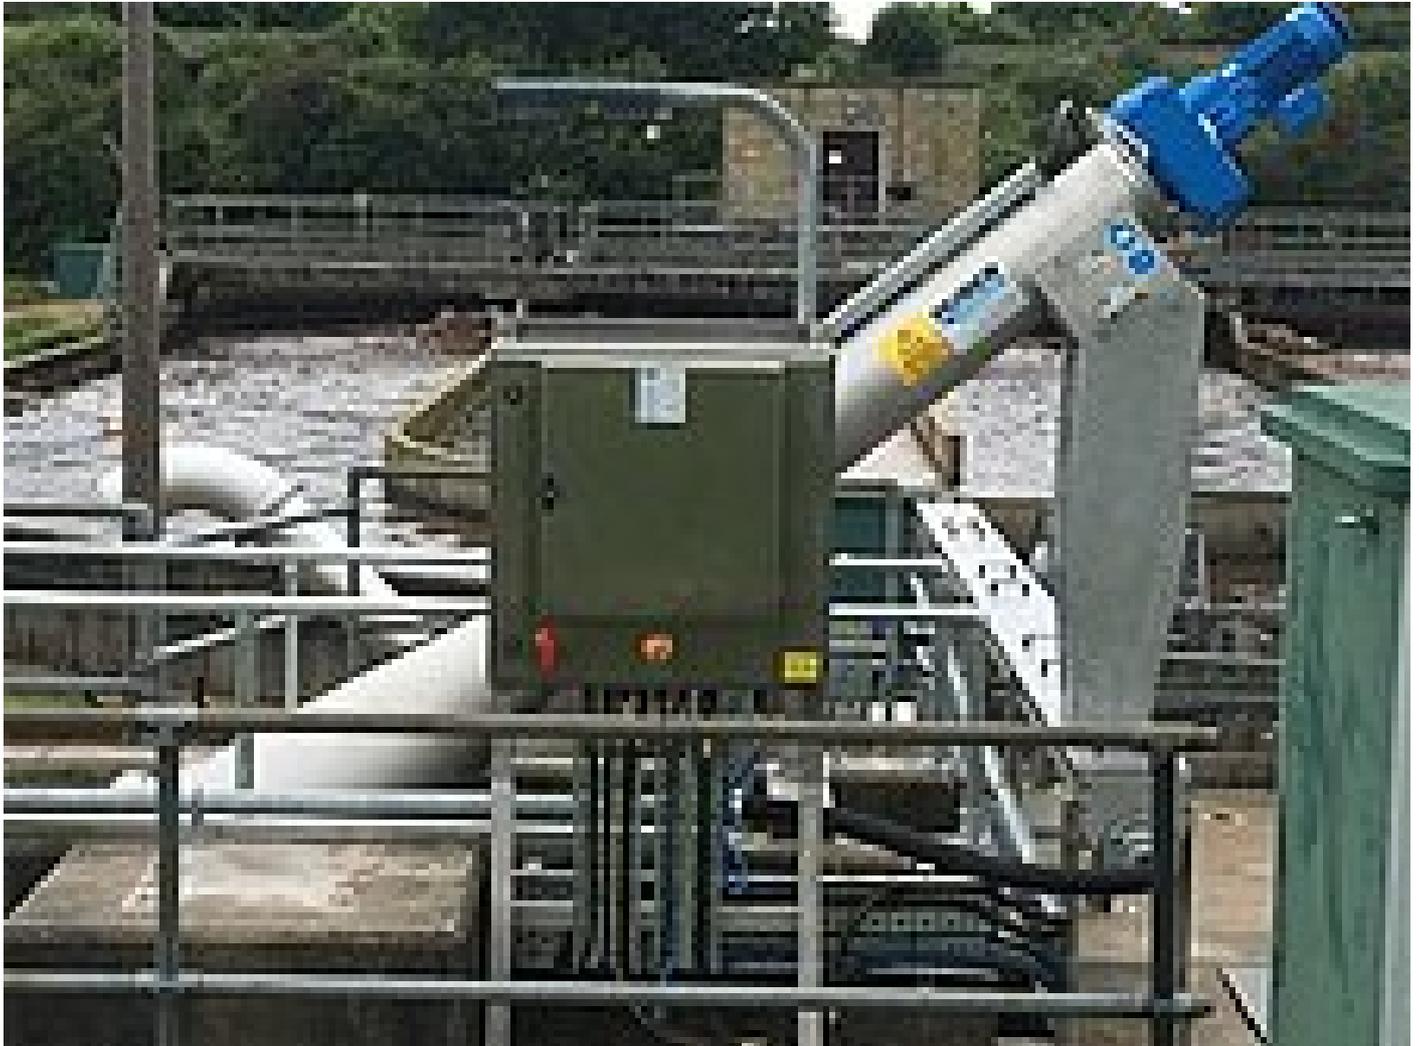
HUBER Micro Strainer ROTAMAT® Ro9 installed at Charfield STW

We modified our combined screen (HUBER Micro Strainer ROTAMAT® Ro9) so that it ran without washwater and no compaction, it was essentially a conveyor to elevate the screens into a small washpactor (Washpress WAP®/L). This Inlet screen was one of the first Ro9's without the washwater feature to be supplied into the UK for the Wessex Water inlet screen replacement projects. This innovative idea of discharging from the Ro9 into a launder was a success and is currently working extremely well.

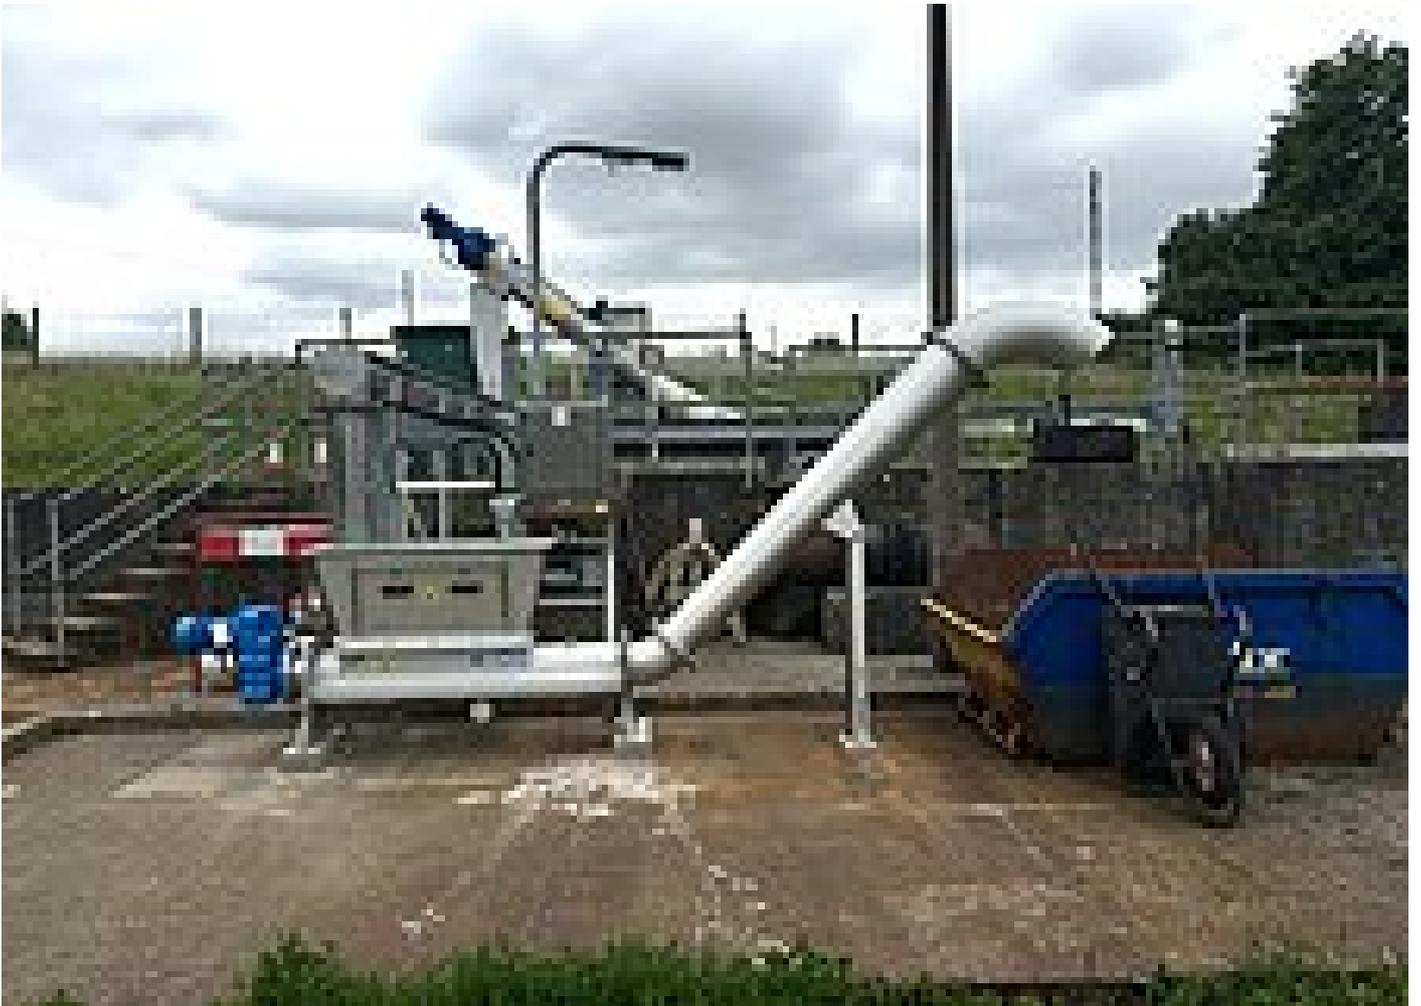
The complete HUBER installation with Wash Press WAP®/L in the foreground

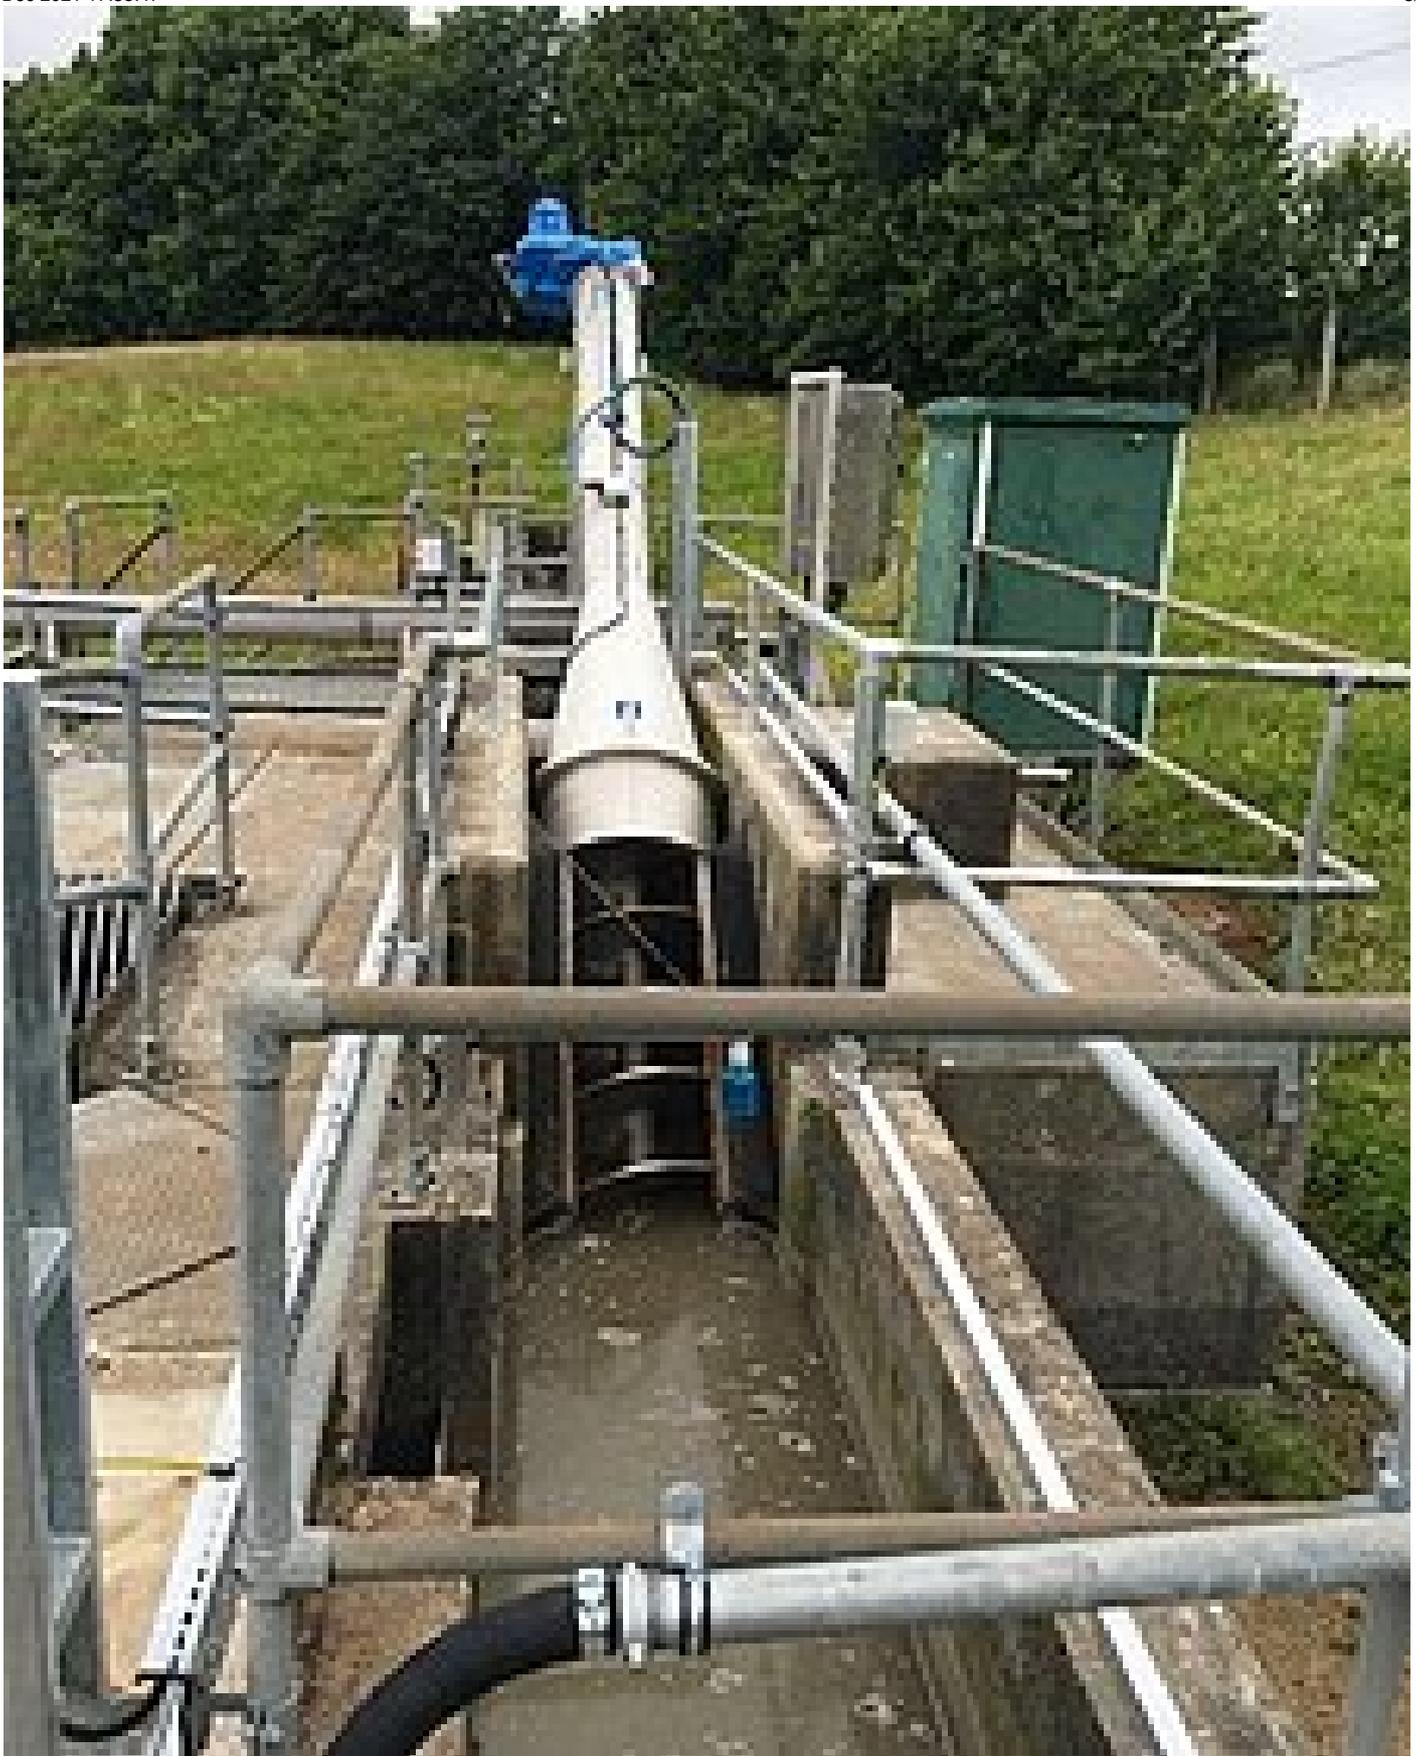
The modified HUBER Micro Strainer ROTAMAT® Ro9 in the inlet screen channel

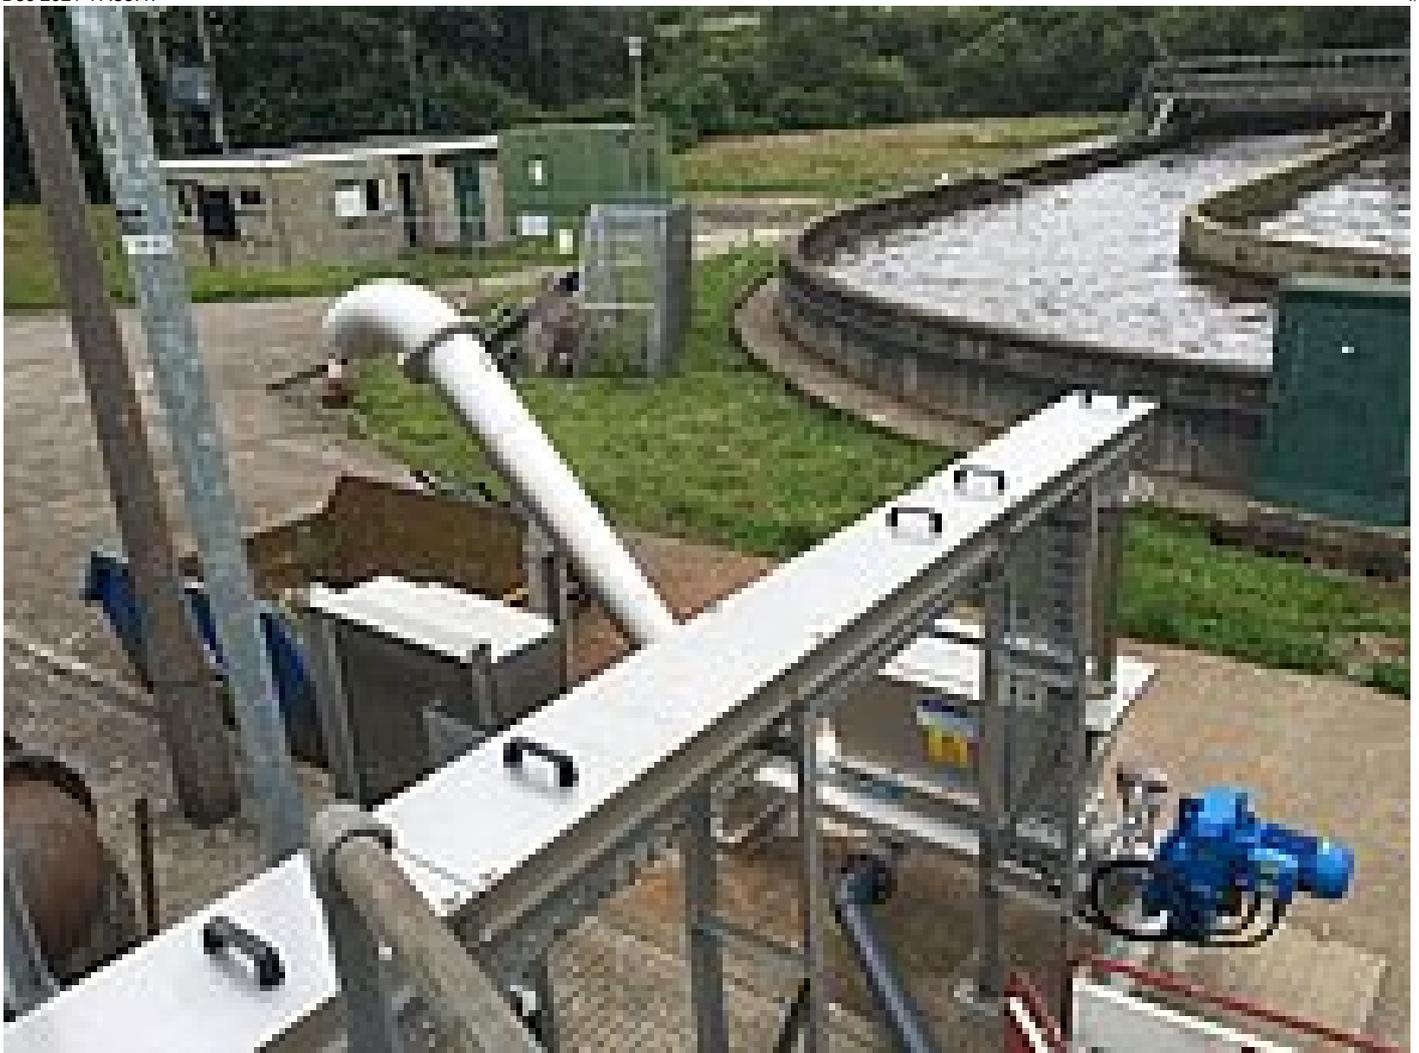
Launder Channel feeding the Wash Press

The lack of washwater for the launder resulted in an additional modification - Wessex Water fitting a submersible pump in a chamber upfront of the screen, this chamber had a 6mm perforated plate upfront to prevent large rag blocking the pump. The pump starter was included in our control panel and was linked to the screen start.

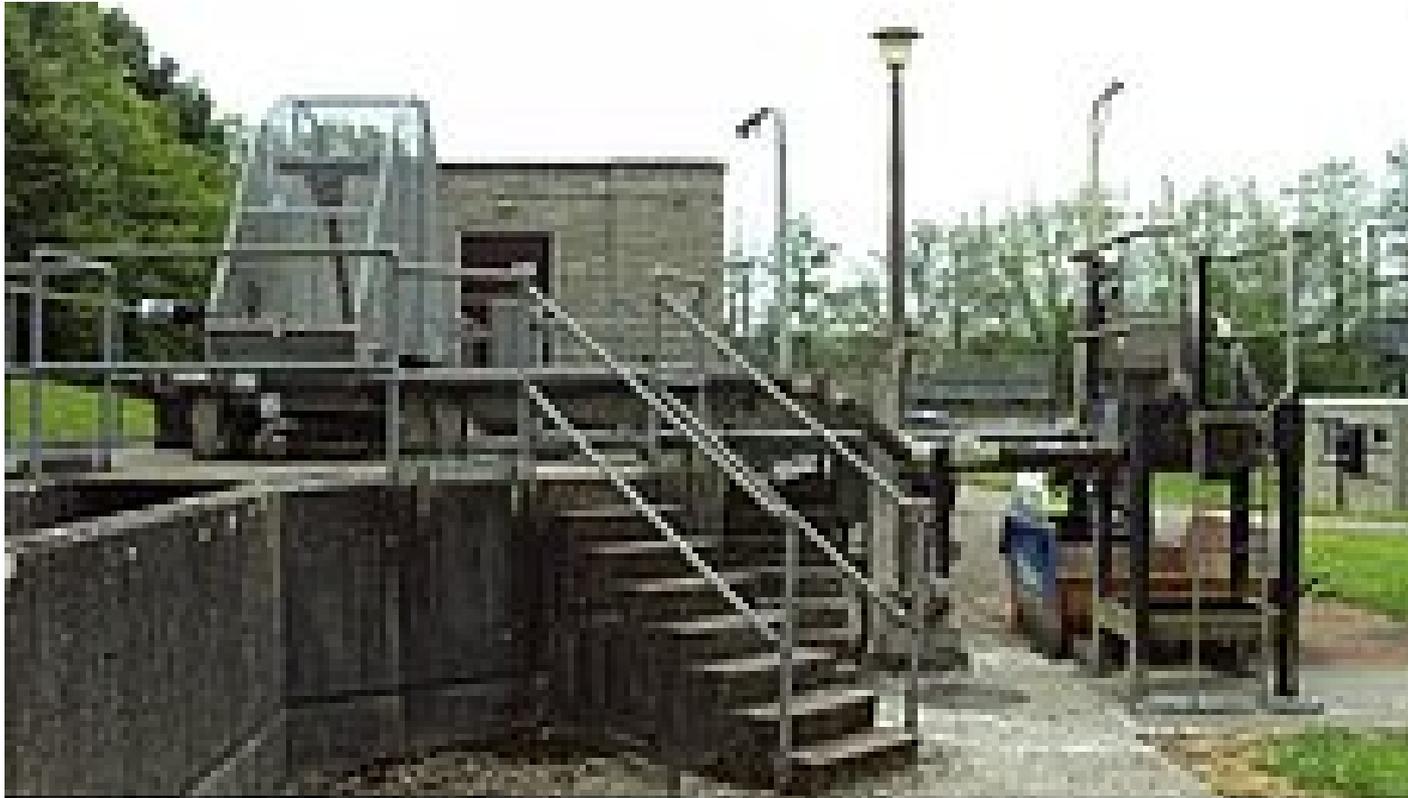
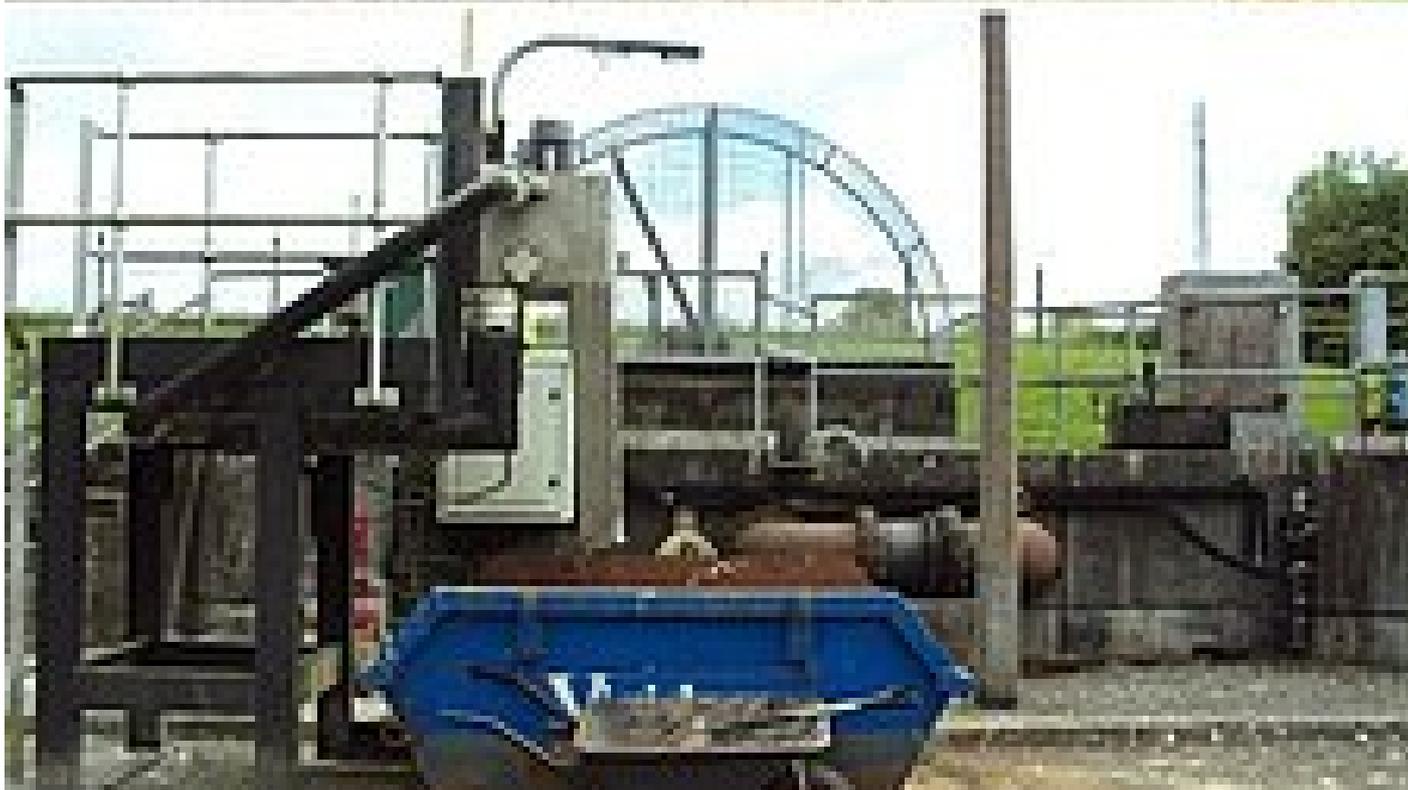
The old equipment installed was at the end of its asset life and constantly failing

Installed on site was an old 20mm bar screen discharging into a launder feeding a macerator and licep unit. All the equipment installed were at the end of their asset life and were constantly failing. The inlet screen was also allowing rag to bypass it due to its age.
