## Solution for Plugging Problems in Wisconsin, USA

The Village of Oostburg, WI was experiencing clogging problems throughout their wastewater treatment plant. The clogging was due to a malfunctioning comminutor of their influent pump station in their headworks structure. The existing grinder was often out of service and repairs were very costly. It was the desire of the City to upgrade the plant by installation of a fine screen.

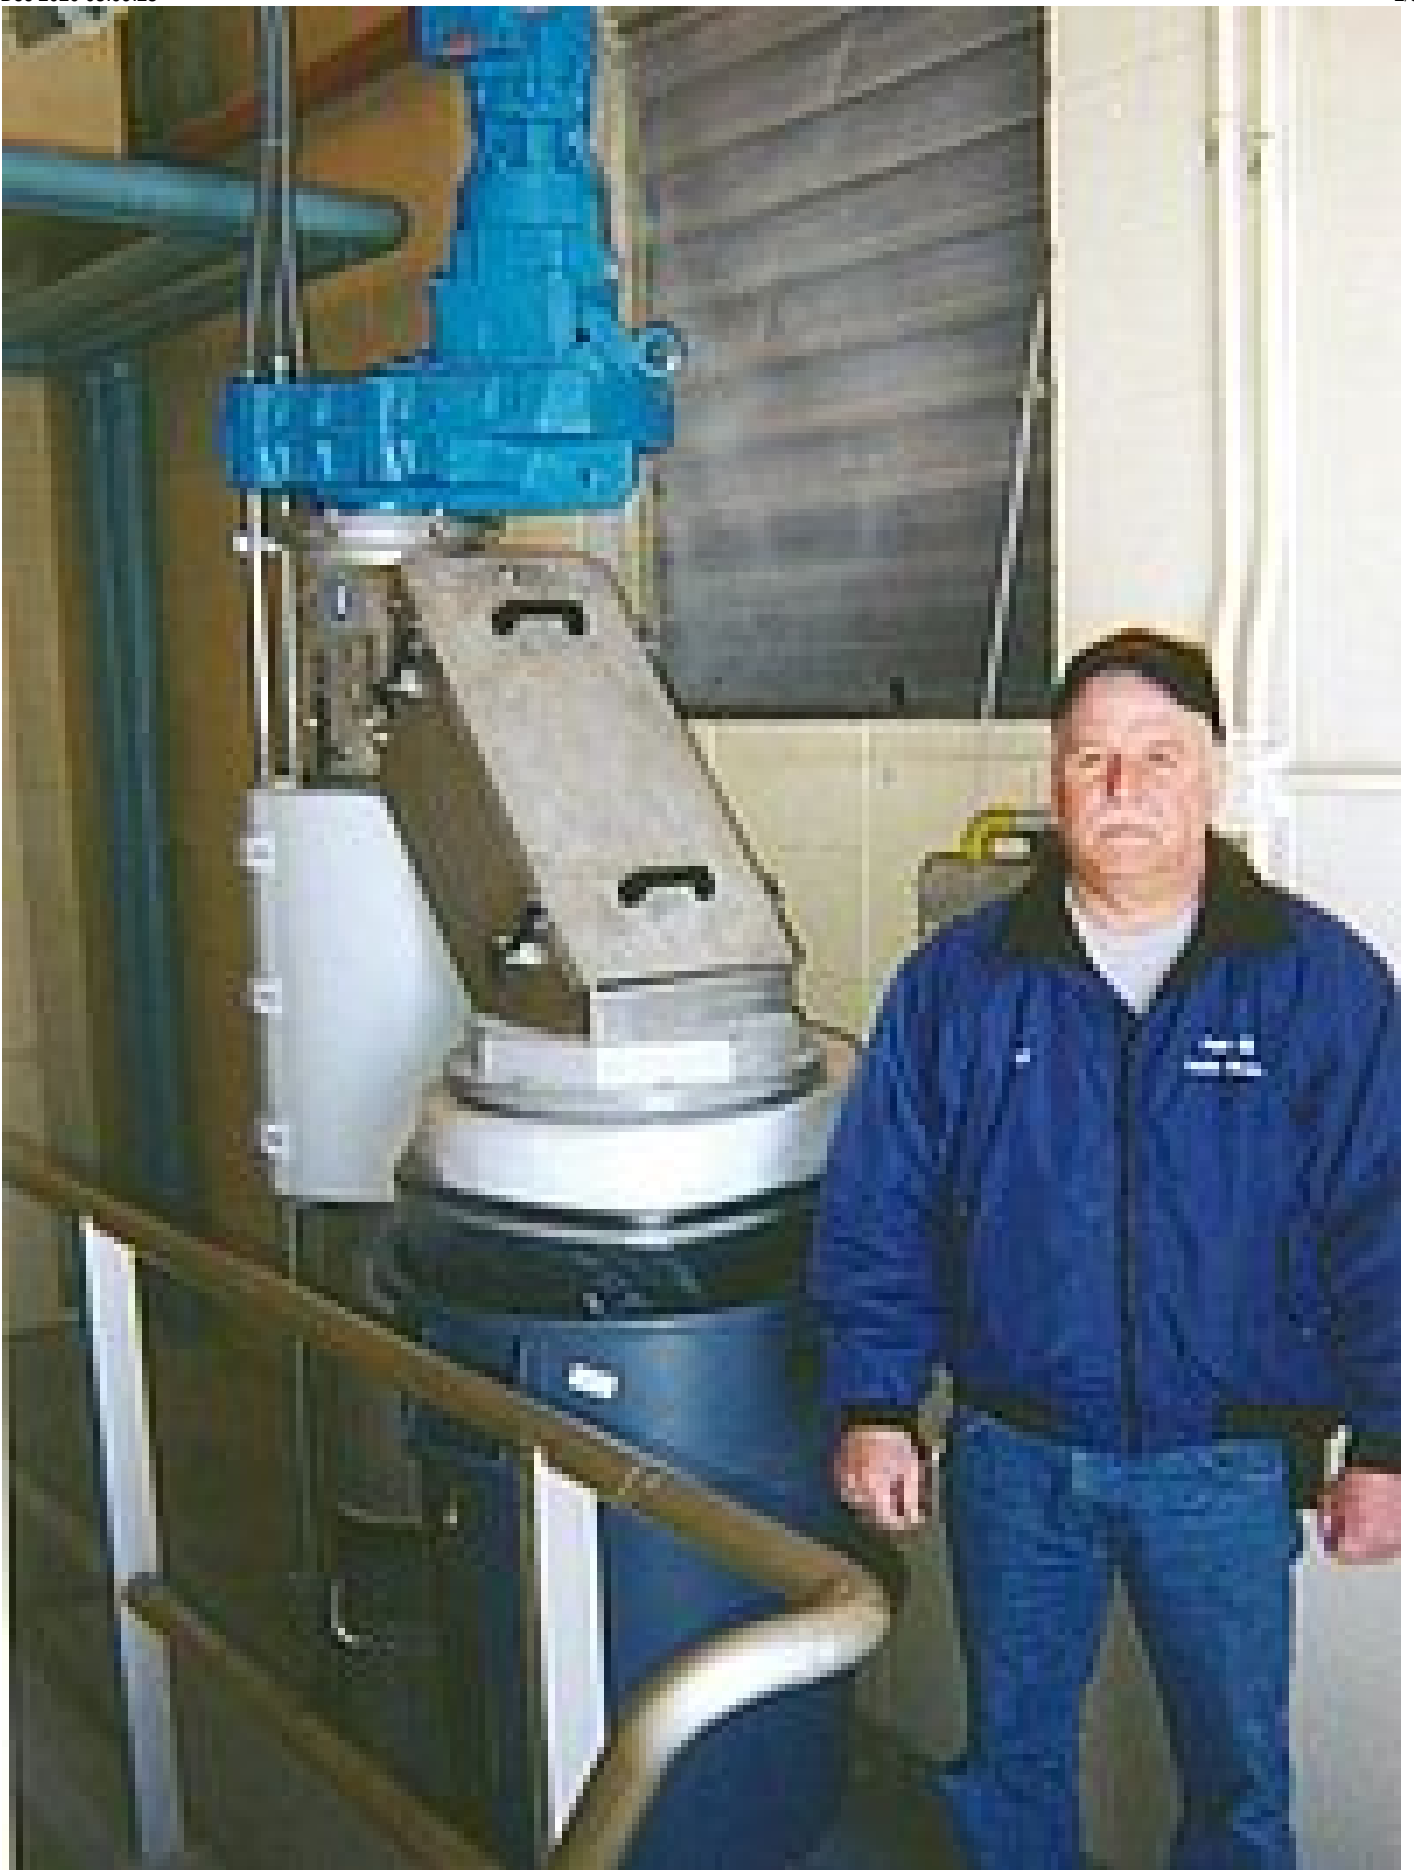
Chief Operator Phil Dulmes: „This is the best thing we ever did. We no longer have to manually clean out rags and other debris“

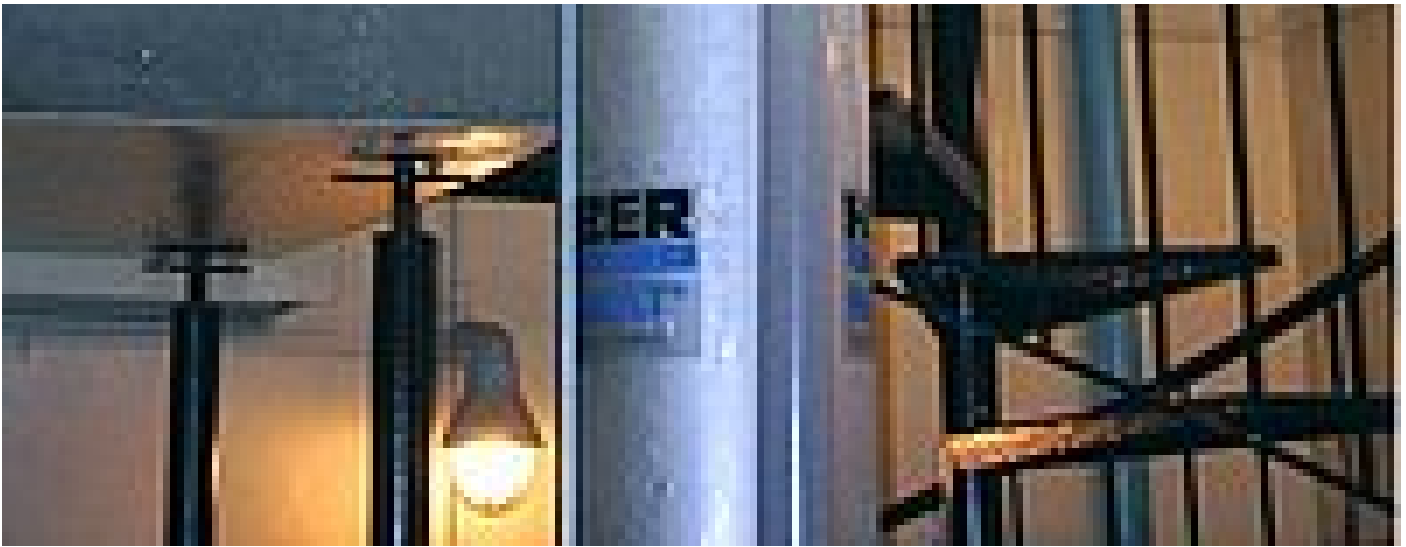
Vertical screenings transport tube of the RoK 4

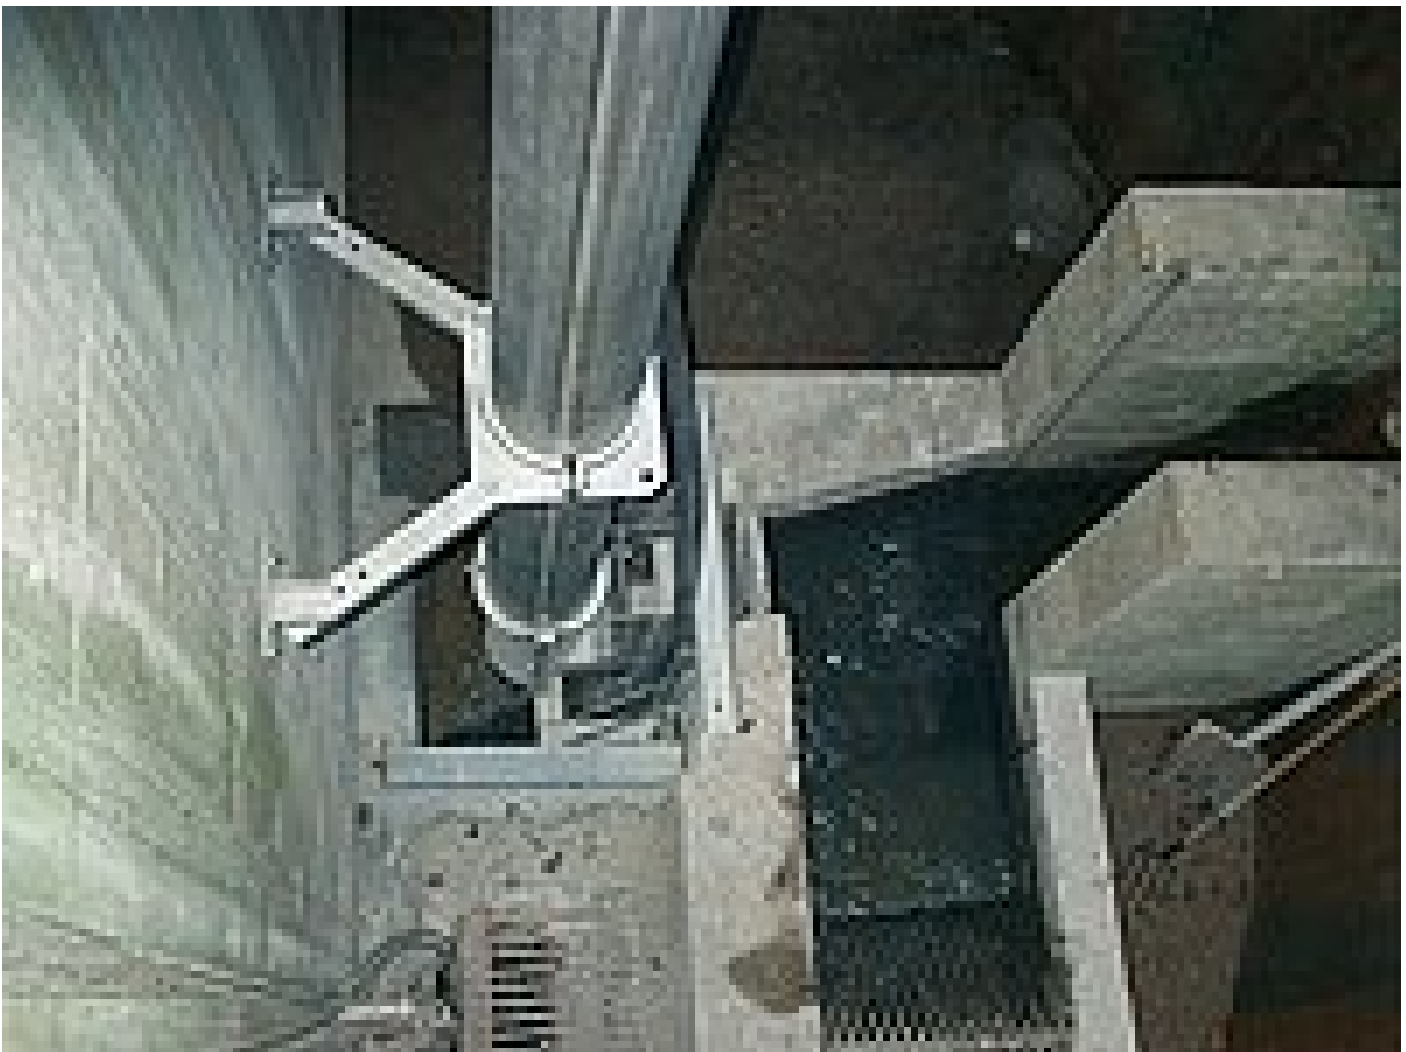
Lower section of the RoK 4 with screen basket and IRGA for screenings washing

We modified the standard machine's piped inlet to match the inlet-channel's rectangular cross section. We accomplished this by removing the pipe inlet and modifying the inlet box with angles that could be attached to the channel. The design team working with HUBER engineers came up with a clean, safe and cost effective solution. The plant has not experienced any clogging problems since the screen was brought online. The Village of Oostburg is very satisfied with the performance of the new screen.
